Subject: Alexandria landfill slope failure

Site Inspection Report - St Peters Interchange Slope Failure (Previously Dial a Dump Industries)

Geotechnical Desktop Study and Slope Risk Assessment

WestConnex - St Peters Interchange (SPI)

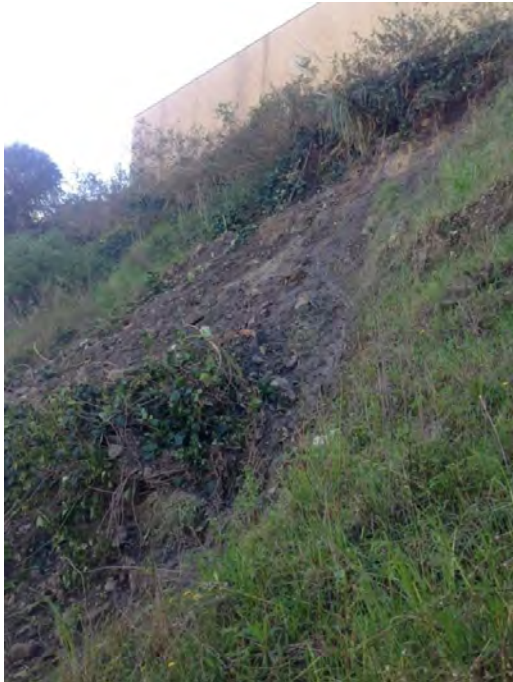
The slope failure occurred on an embankment near the north western boundary of the site. The embankment is estimated to be 22m high based on survey information from the Westconnex GIS. The surface of the embankment was covered in grasses, shrubs and small trees. The surface materials typically comprised gravel and cobbles of sandstone and bricks in a silty sand matrix. Adjacent to the embankment is a near vertical 17 to 19m high siltstone cutting. Above the embankment and siltstone cutting are commercial buildings, an access road and car parking. A photo of the slope failure is shown in Figure 2 below.

The majority of the existing embankment is at a 1H:1V slope. However, based on visual observations it is estimated that the slope angle at the crest of the embankment increases to an angle of between 50° and 70° from horizontal. Undercutting of the slope failure scarp at the embankment crest was also observed beneath the roots of the trees and shrubs.

Figure 2 Fill embankment looking west showing the landslide (6th May 2015)

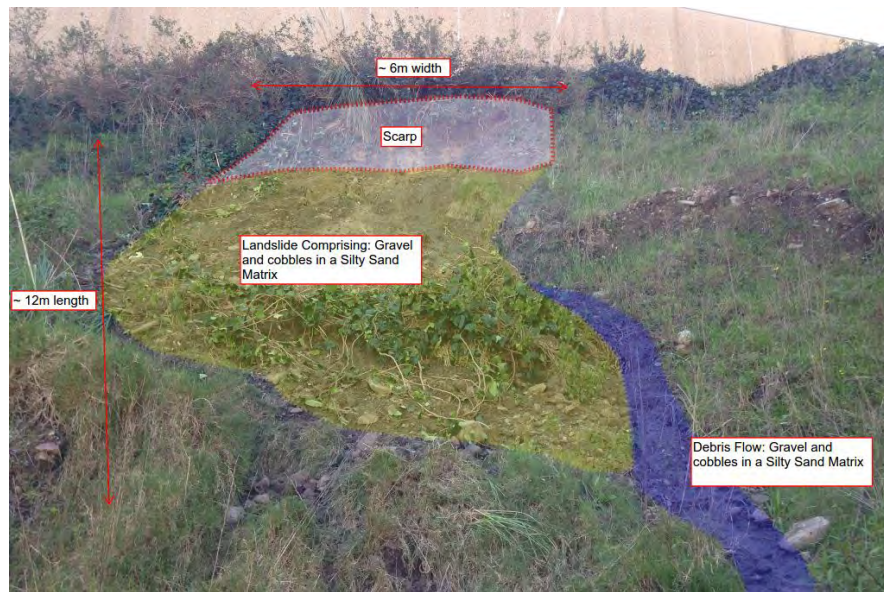
Based on a visual assessment of the embankment, it is estimated that the size of the slope failure is 6m wide, 6m in length and 0.5 to 2m deep.

The slope failure appears to have travelled approximately 3m to 6m down the embankments. A debris flow was also noted on the northern side of the landslide, however it is unclear if this occurred prior to, subsequent to or during the landslide. The general configuration of slope failure is shown in Figure 3 below.

Figure 3 Landslide configuration and materials (6th May 2015)

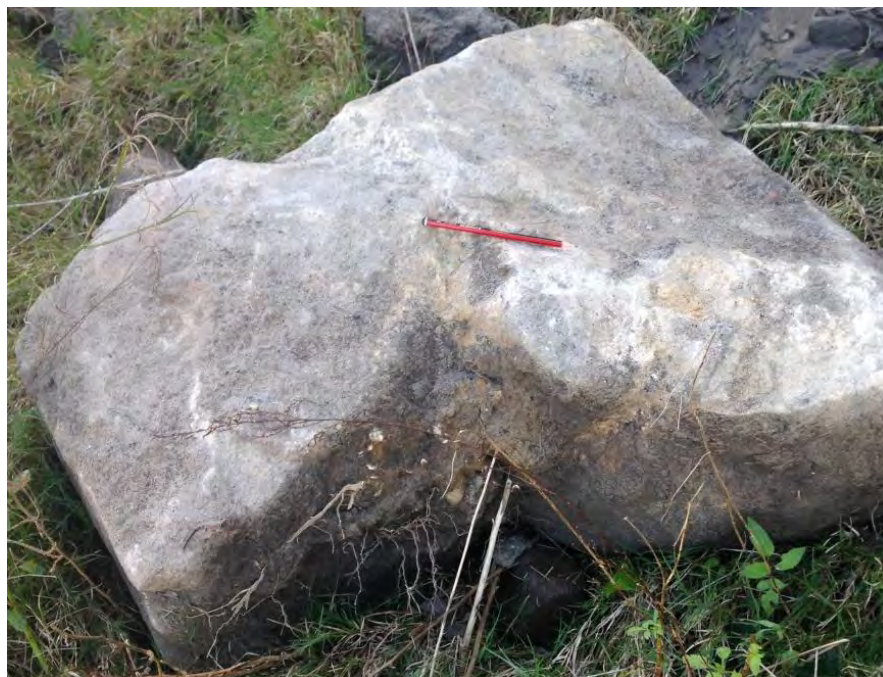
A boulder from the recent landslide, approximately 1m in diameter, was noted 5m from the toe of the slope failure. A photograph of the boulder is shown in Figure 4 below. The landslide materials comprise fill typically containing silty sand, cobbles and boulders of sandstone and bricks.

Figure 4 Boulder from Landslide (6th May 2015)

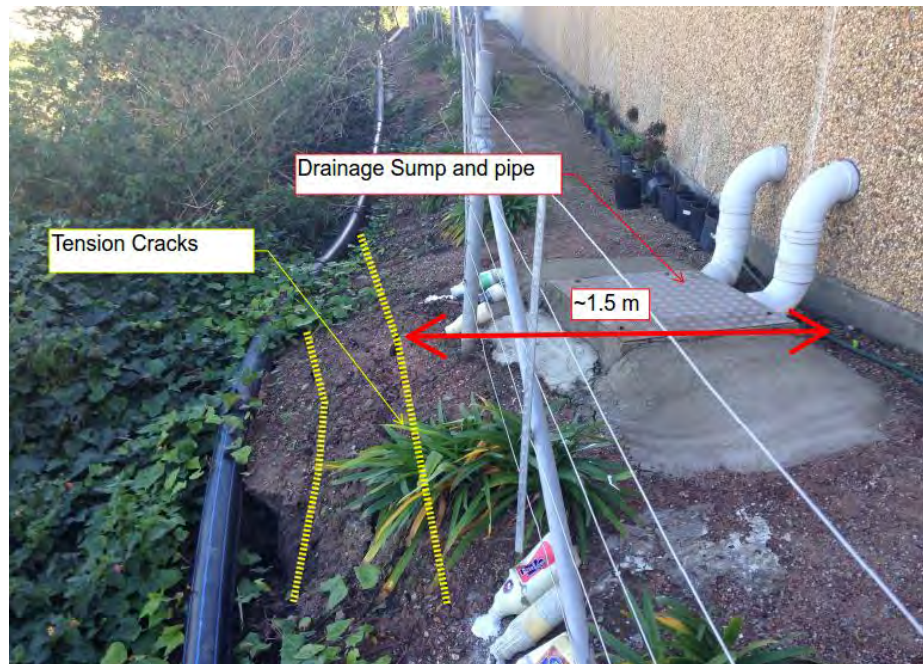
During the site visit on the 20th of May 2015, tension cracks were observed at the crest of the slope above the slope area, as shown in Figure 5 below, indicating that the embankment may be exhibiting evidence of regression.

Figure 5 Crest of slope, showing tension cracks and drainage sump and pipe (20th May 2015)

- Damage to the drainage sump and pipe immediately above the slope failure
 - Surface water runoff
 - Blocked drains causing potential runoff down the embankment

- Cover the top of the slope with plastic to prevent further water ingress to the slope in the vicinity of the failure and tension cracks
- Monitor further ground movements around the slope area daily and any other observable changes

- CCTV inspection of the drainage sump and pipe above the slope failure (it is understood that this work has been organised by WDA);
- Installation of an Inclinometer from the crest of the slope to monitor movements (if safe to do so);
- Slope stability assessment of the existing slope and options for stabilisation of the slope to maintain the existing building stability;
- Slope surveyor monitoring; and
- Dilapidation survey/condition report of the warehouse at the crest of the slope (costs can be provided if requested).

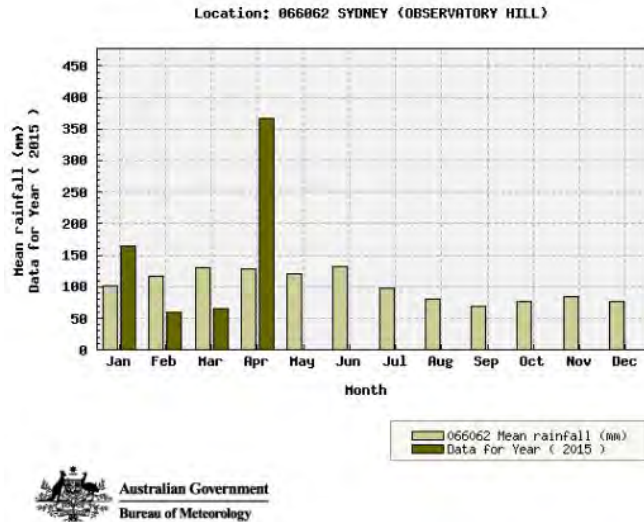
- The heavy rainfall in April will likely have saturated the slope, resulting in a reduction in strength of the supporting materials. The total rainfall at Observatory Hill was 366.8mm in April, nearly 3 times the recorded average of 128.6mm (Bureau of Meteorology).
- The existing slope of the embankment comprises uncontrolled fill material. The batter angle is considered steep for this material.
- Drains along the access road at the top of the slope are blocked causing potential runoff down the slope causing erosion and saturation of the embankment

Figure 6 Monthly average rainfall and recorded rainfall for 2015

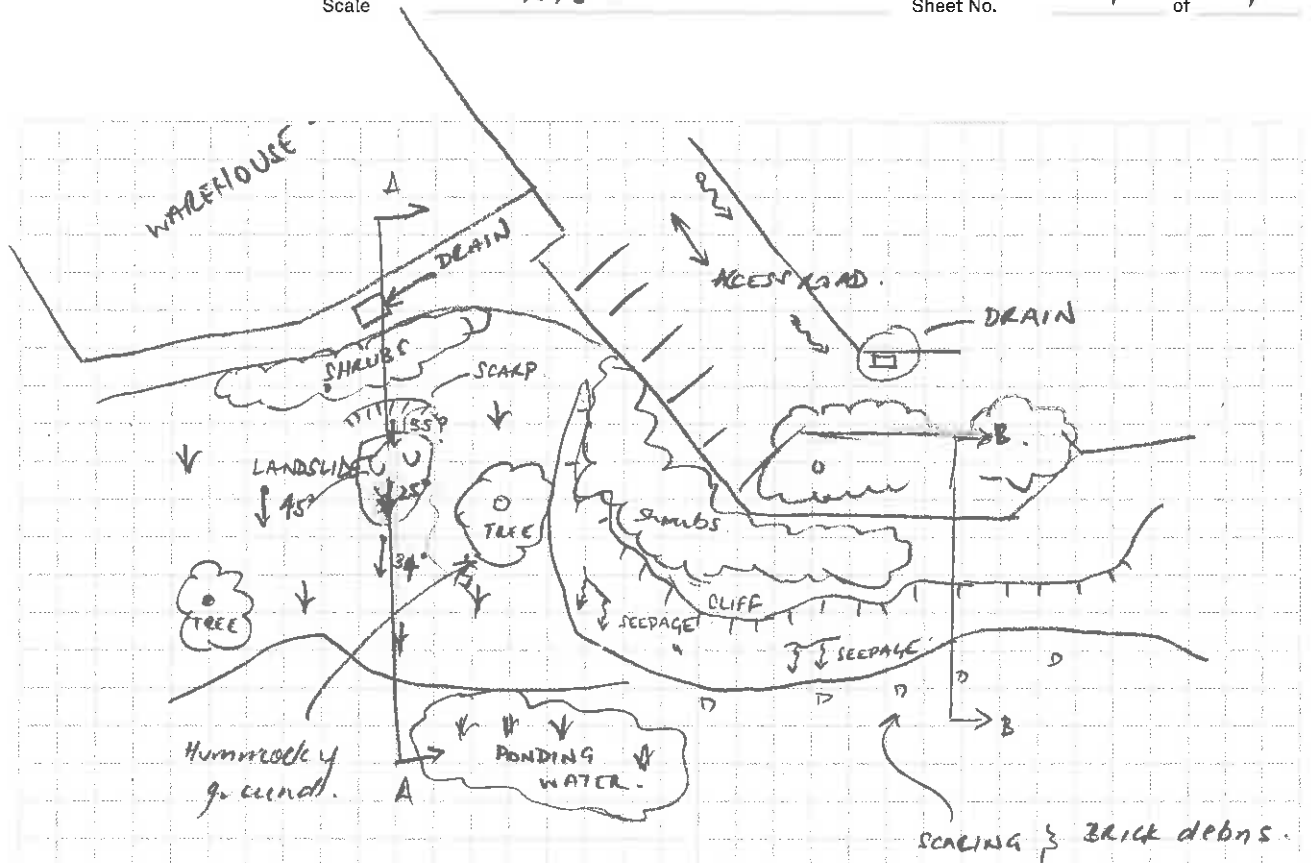
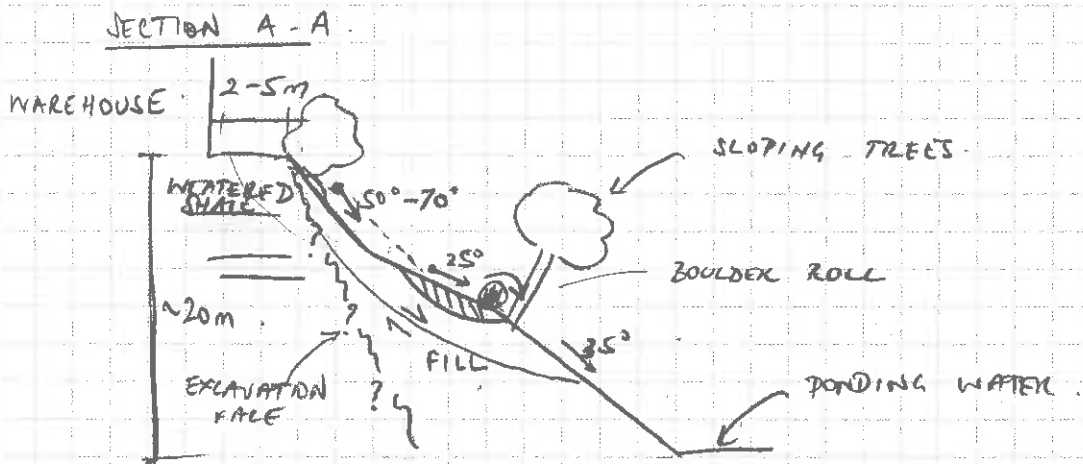
Job Title	WESTCONEX - ST PETER INTERCHANGE		
Job No.	LANDSLIP		
Originator	P. Plummer	Calculation No.	
Reviewer	John Ashely	Date	6/05/2015
Scale	NTS	Date	
		Sheet No.	1 of 1

A sketch of the slope area based on visual observation with typical sections through the embankment have been provided in Attachment A.

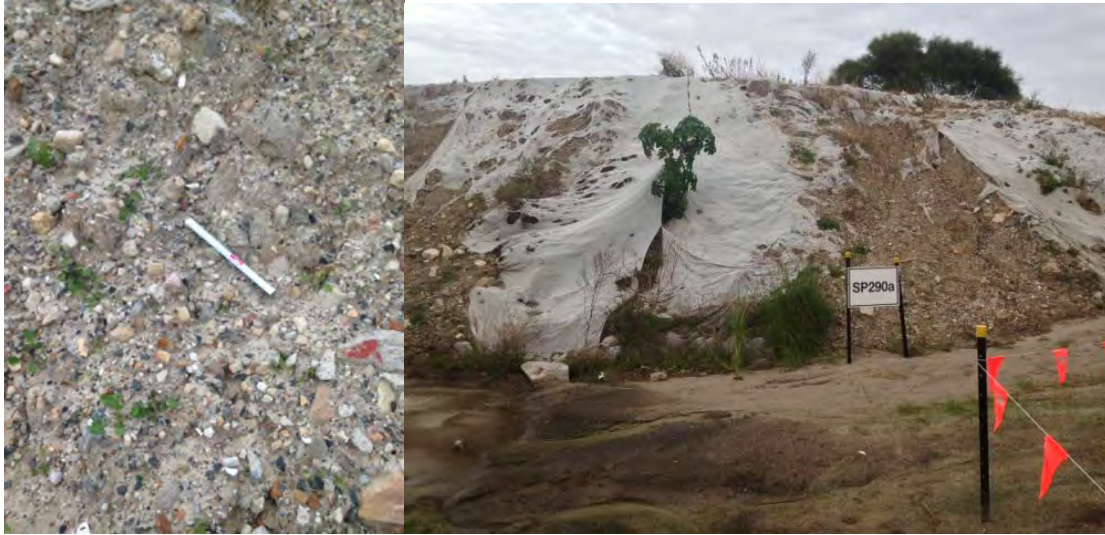
Figure 3 Stockpile SP290a

Based on site observations and the laboratory testing results these materials could be used to form the proposed buttress, provided all oversize boulders break down to less than 2/3 the compacted layer thickness or are removed.

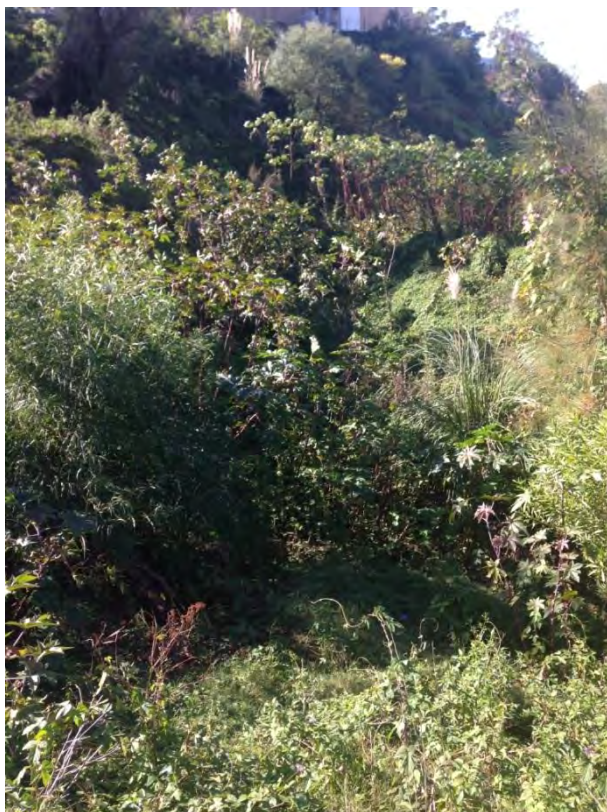
Plate 1-2 - Low point of the slope, evidence of ponding water

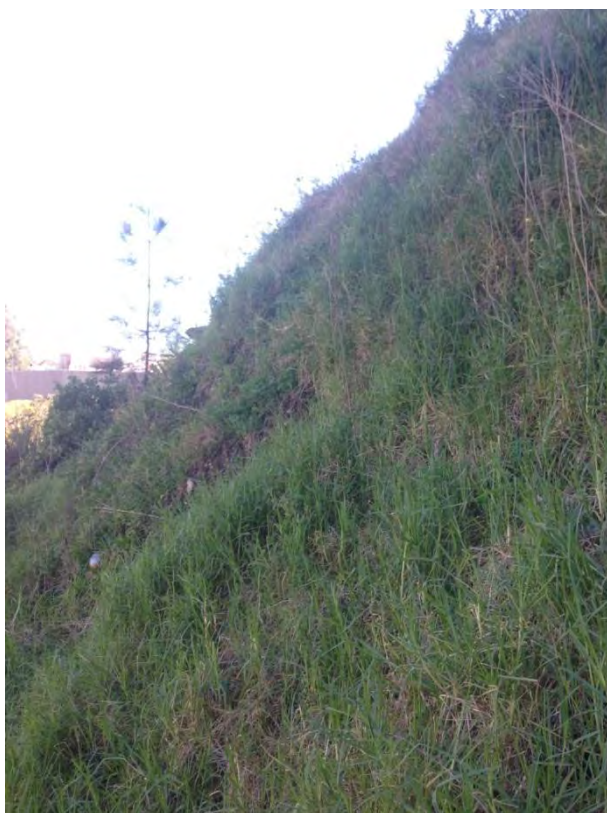
Plate 2-4 - View looking North West along the slope face at potential historical failure

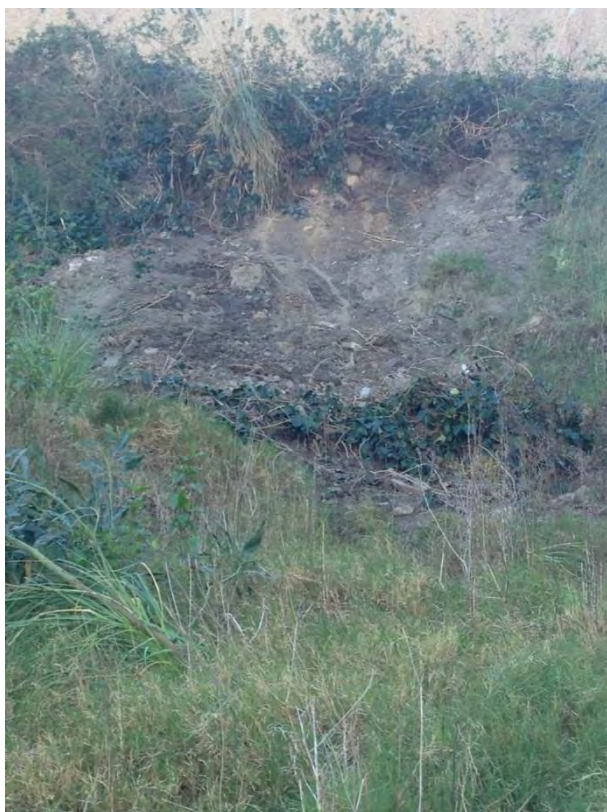
Plate 2-5 – View looking North at slope failure above the existing warehouse/commercial building

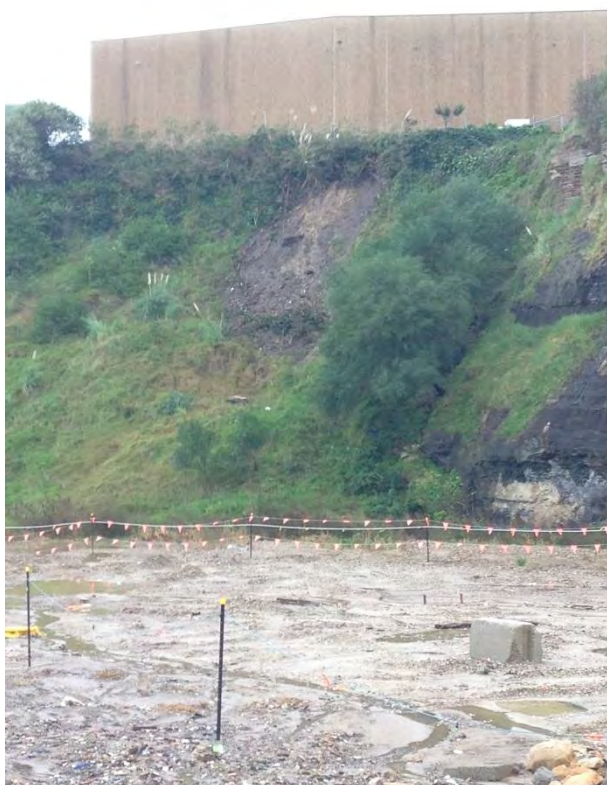
Plate 2-6 – View looking North at slope failure

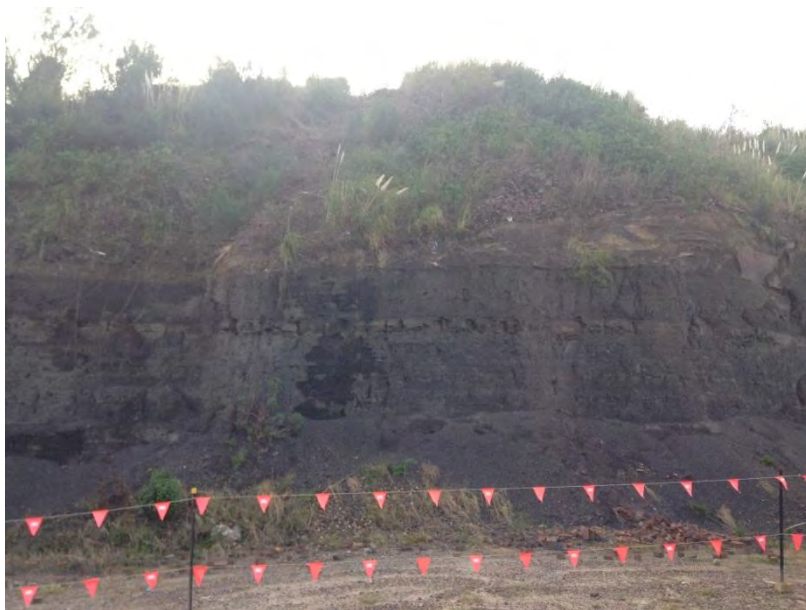
Seepage from a number of the exposed shale bedding planes was observed.

Plate 3-3 - View looking north at exposed quarry face with fill overlying the weathered shale and seepage from bedding

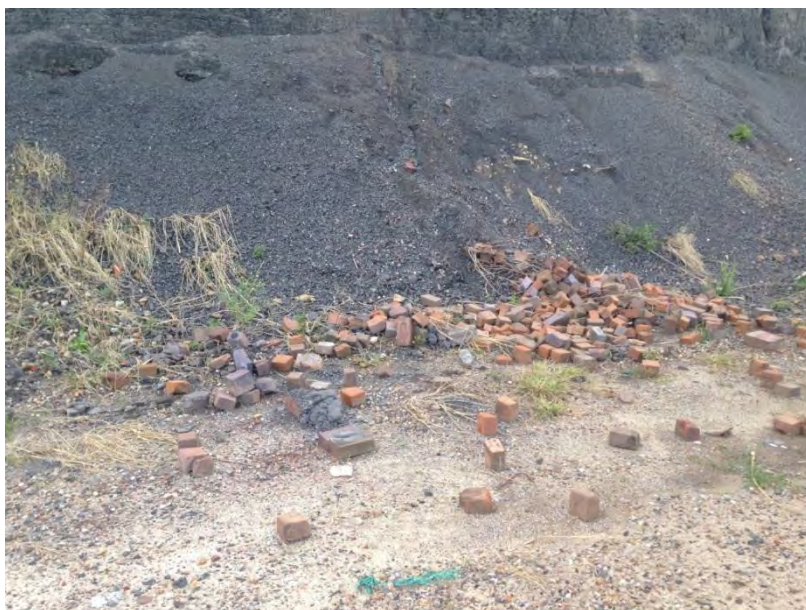
Plate 3-4 – Talus build-up and fill (bricks) at the base of the slope

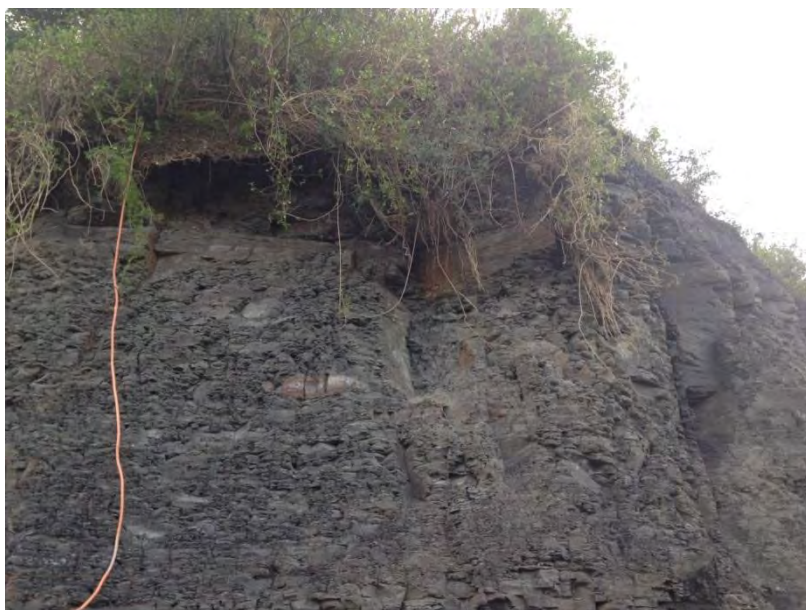
Plate 3-7 – Overhanging section of exposed cut face where previous small block has fallen out

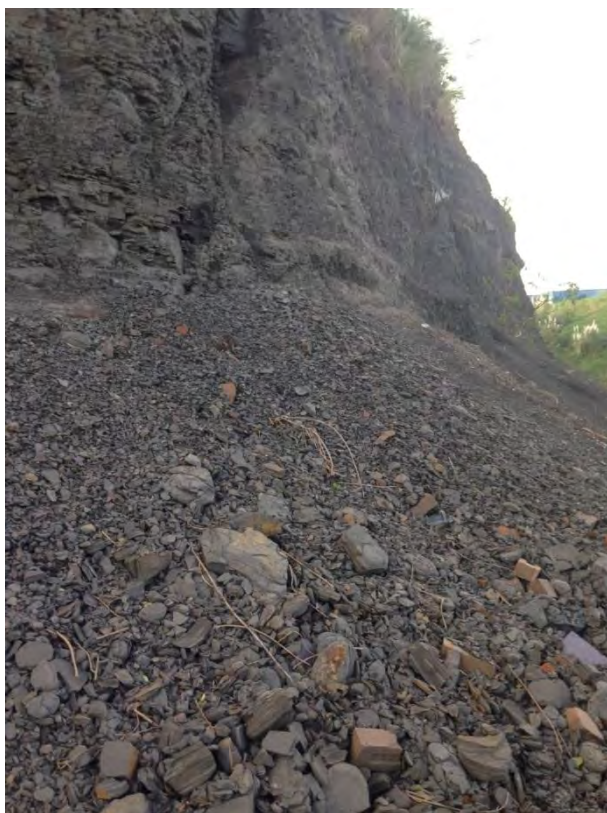
Plate 3-8 – Talus build-up (spalling, small blocks and bricks)

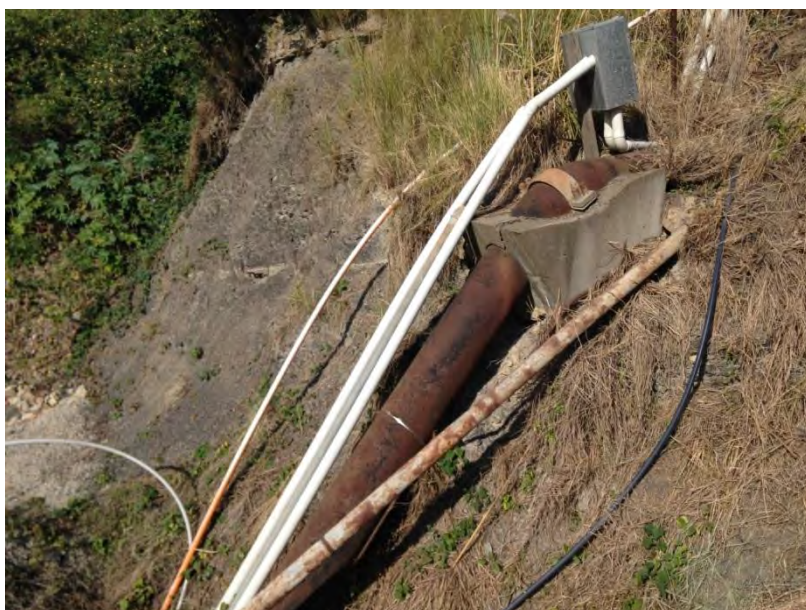
Plate 5-4 – Services into the landfill from Canal Road (likely for Leachate Riser), Exposed quarry face

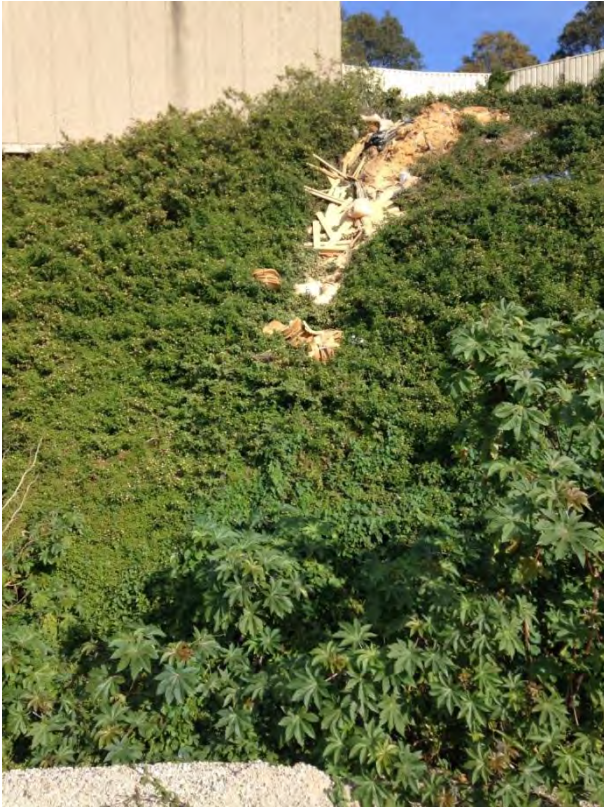
Plate 5-5 – View looking West at overall slope, slope obscured by dense vegetation, illegal dumping into the site also noted on the slope.

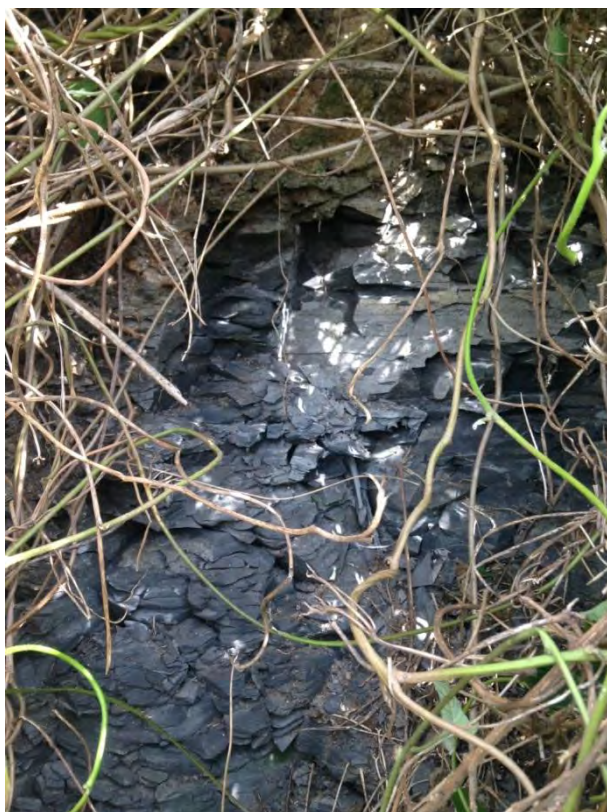
Plate 5-9 – Exposed Siltstone quarry face observed in dense vegetation
