# Summary of existing information from desktop study

## Previous reports

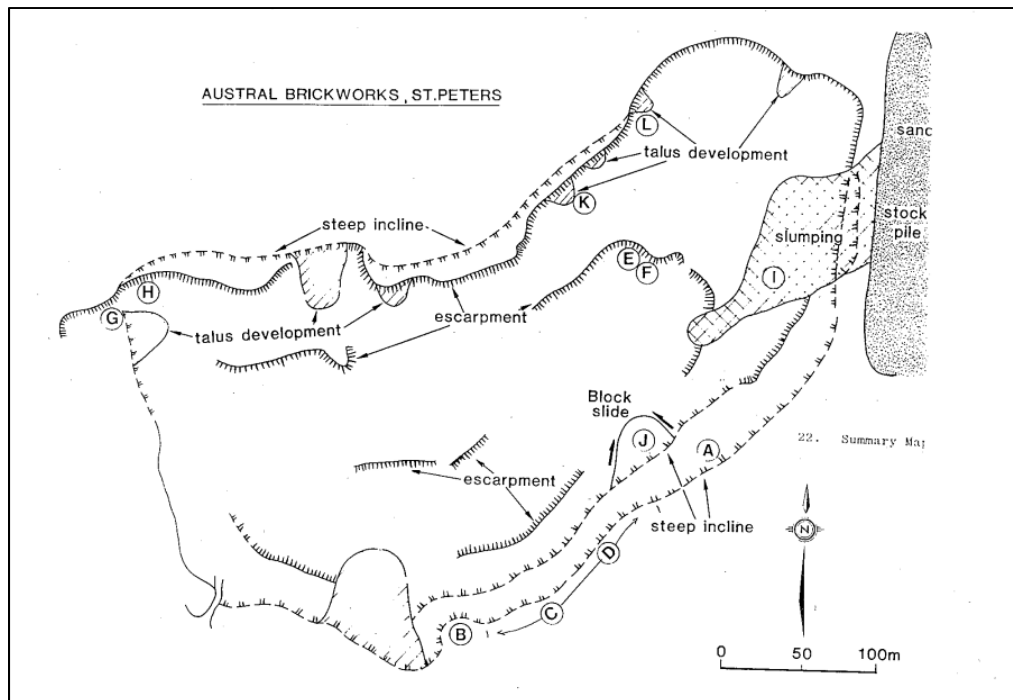
**Figure 5** Significant geological features, extract from Ref 3

Location	Feature
A	Ashfield shale and Botany Sands Contact
B	Botany Sands/Laterite/Shale Contact
C-D	Fossil Shell occurrence in Sand
E	Intersecting faults
F	Fault and Joint Zone
G & H	Fault through weathered Shale
I	Man-made slump
J	Old Slip Area

Location	Feature
K, L	Talus Cones and Block Failure
M, N	Groundwater ingress

- Feature I, Slumping / debris flow of the stockpile material located at the north eastern corner of the quarry (area known as Bradshaw Mountain);
- Feature J, a mass siltstone block slide at the southern boundary of the quarry;
- Talus developments which had stabilised at an angle of 32° at various locations around the site; and
- Frequent rock falls noted at various locations around the quarry wall.

The report suggests that the cause of the various slope failures is linked to groundwater flow into the quarry at a number of points and to the presence of consistent near vertical joints orientated at 020°. The quarry was identified as 'not static' even though excavation of the shale had ceased at the time of the report. Stabilisation measures recommended in the report included either buttressing the unstable slopes or controlled removal of the unstable areas.

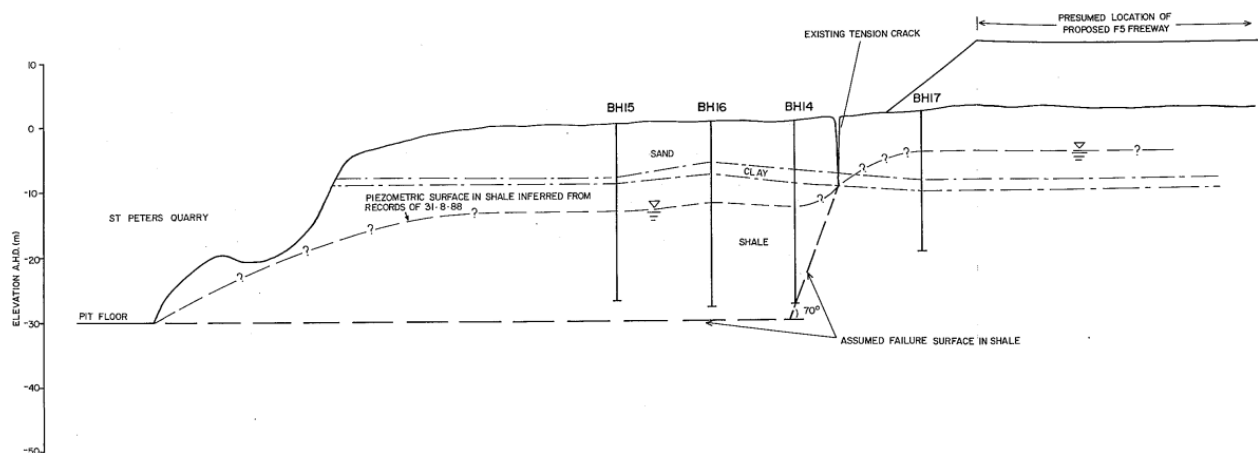
**Figure 6 Cross-section of Slide Area – Presumed failure surface, extract from Ref 6**

The report identified shear zones within the shale, potentially associated with the block failure, at RL -25.5 m AHD and RL-19.5 m. The report considered that the driving force behind the movement of the block was groundwater and that controlling the groundwater may help stabilise the block failure.

A conceptual cross-sectional model of the presumed block was developed as part of the report and is reproduced in Figure 6

The preferred option to stabilise the slope included lowering the groundwater by the placement of horizontal drains near the base of the pit. This was considered to be the most economical means of stabilising the slope. However, the assessment also concluded that the lowering of the piezometric surface using horizontal drains would still limit the allowable height of the embankment of the freeway adjacent to the quarry.

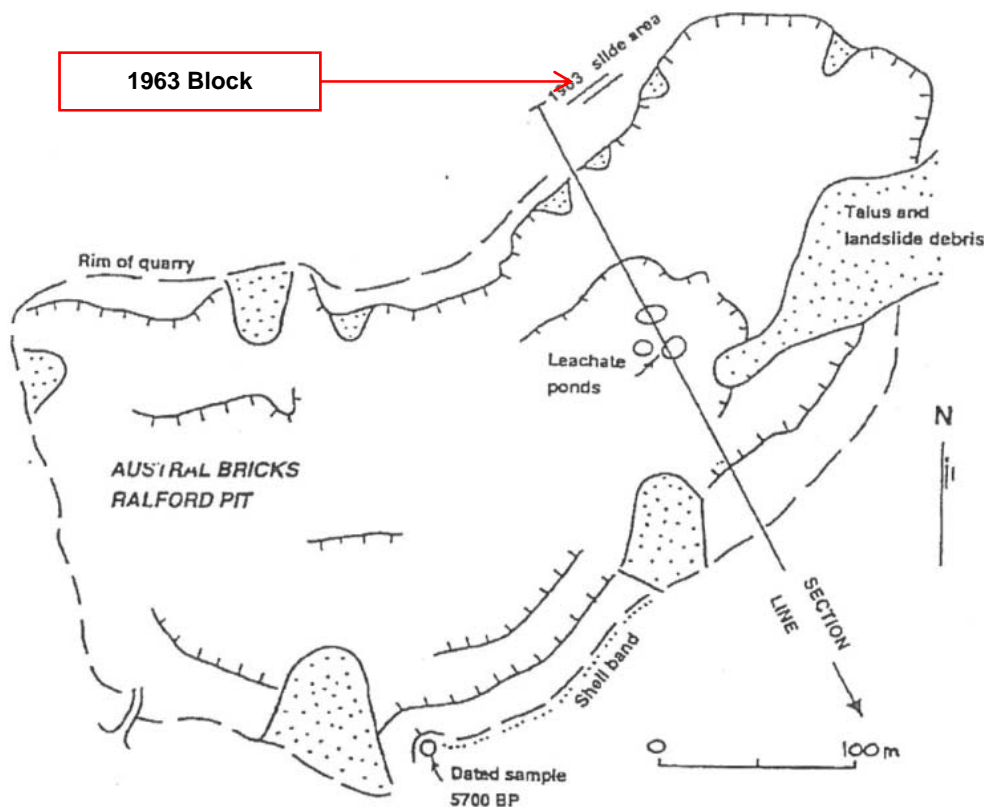
Figure 7 Site Elevation Plan extract from Ref 7

The paper reports that considerable slope instability in the walls of the quarry was recorded as shown Figure 7. The majority of the debris attributed to spalling of the exposed siltstone quarry faces (talus) and slumping of the overlying Quaternary sediments. Two main types of failures were identified:

- block failures due to the persistent NNE trending joints and bedding planes within the shale; and
- slumping of the surficial materials (loose fill, residual soil, colluvium and botany sands).

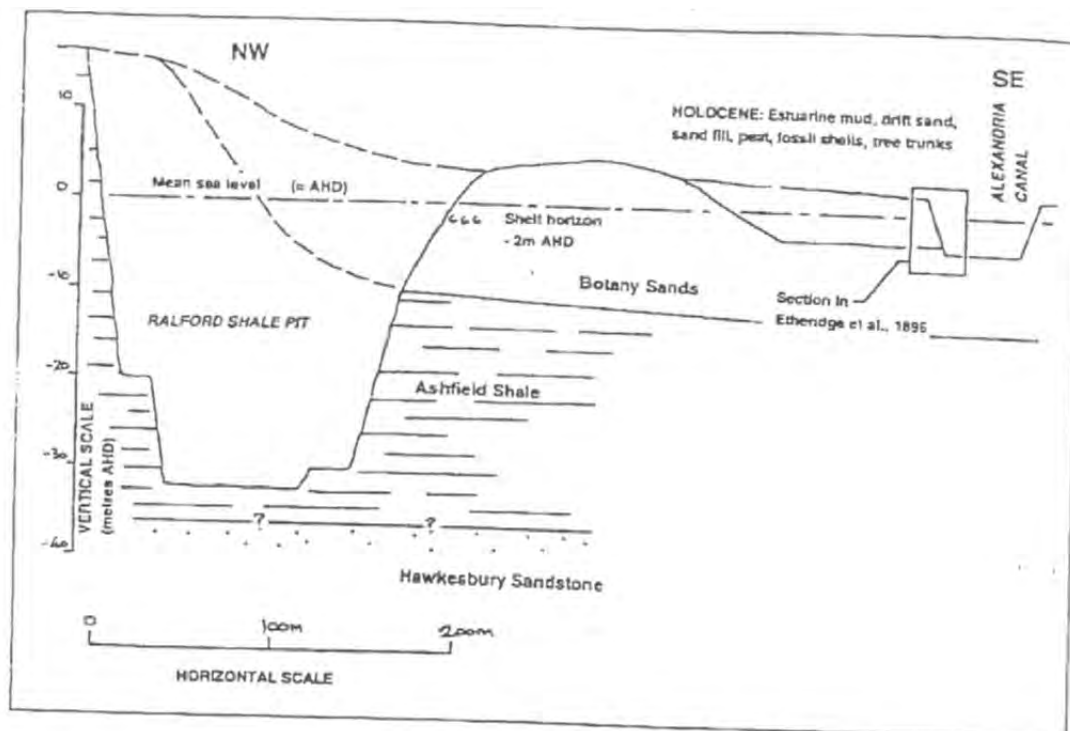
Figure 8 Conceptual cross section of the quarry, extract from Ref 7

A large block failure occurred on the northern side of the quarry in 1963. Tension cracks also opened up between Cowper Street and Bishop Street in St Peters damaging several houses within 100 m of the quarry. The tension cracks were parallel to the quarry face and appeared to have formed along existing joints. It was suggested that the block failure may have caused cracking on the opposite side of the Princes Highway approximately 160 m away. The paper identified the likely failure mechanism as stress relief combined with block movement along the bedding. Groundwater and blasting in the quarry were also considered to be contributing factors to the block failure. The location of the 1963 block failure is shown in Figure 7. Figure 8 shows a conceptual cross section of the quarry reproduced from the paper.

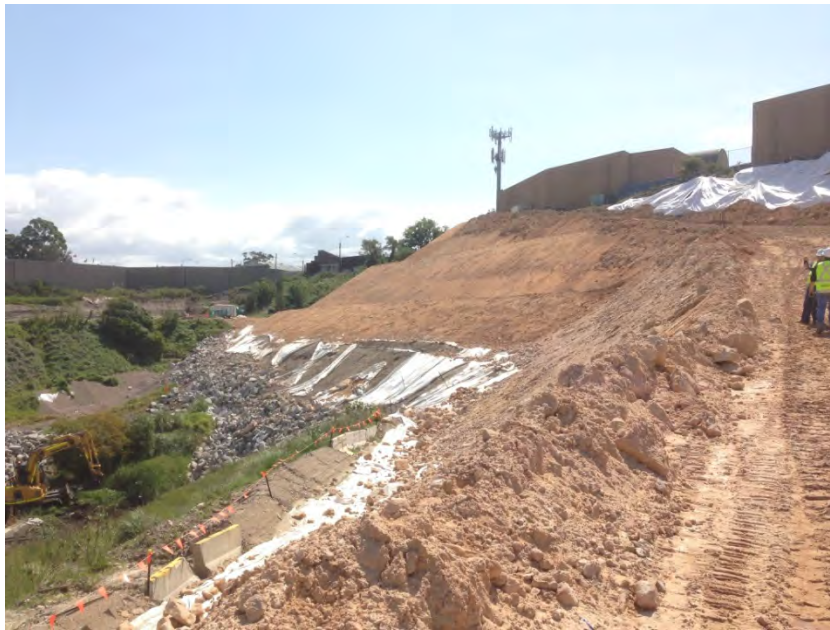
**Figure 11 Construction of Temporary Stabilisation Buttress – 14 October 2015.**

This letter outlines the proposed temporary stabilisation plan for the slope failure that occurred in May 2015 (Slope 2). The proposed temporary stabilisation includes the construction of a fill buttress over the existing steep fill slope, using compacted fill sourced from various stockpiles within the SPI site or imported fill.

The letter forms part of the detailed design of the temporary stabilisation of the slope as shown in Figure 11

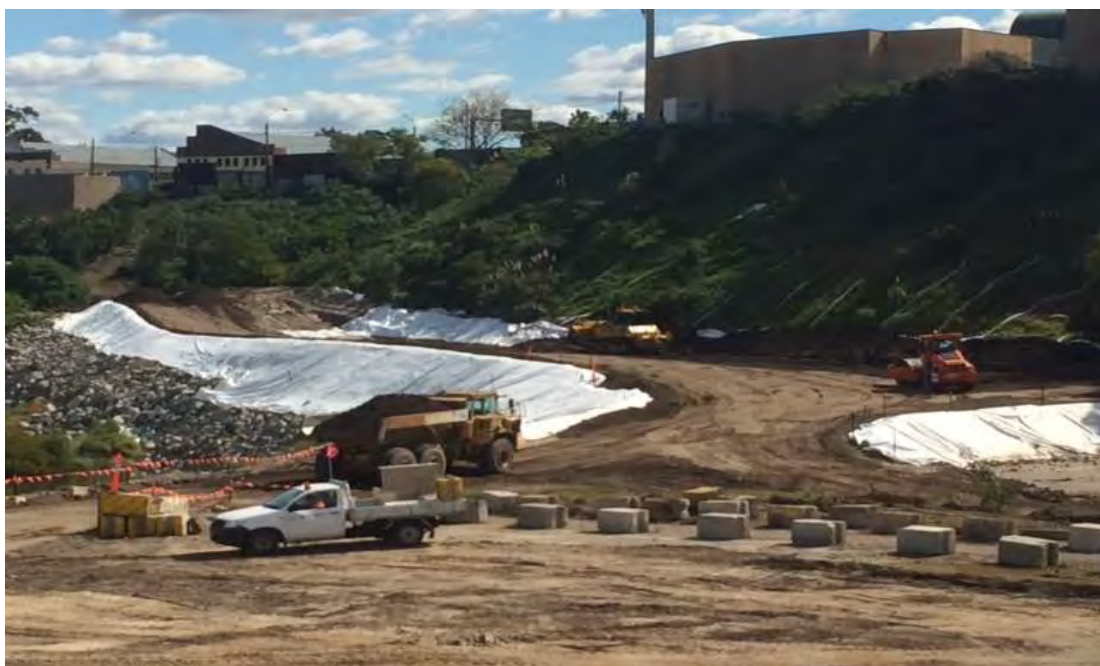
Landslip stabilisation works

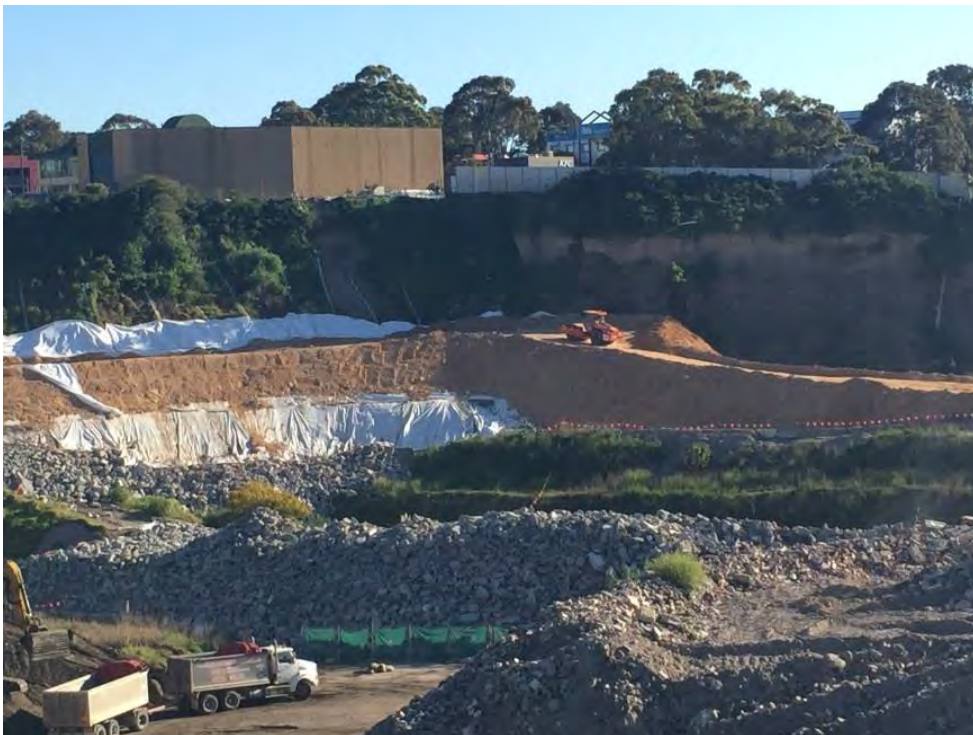
Landslip stabilisation works

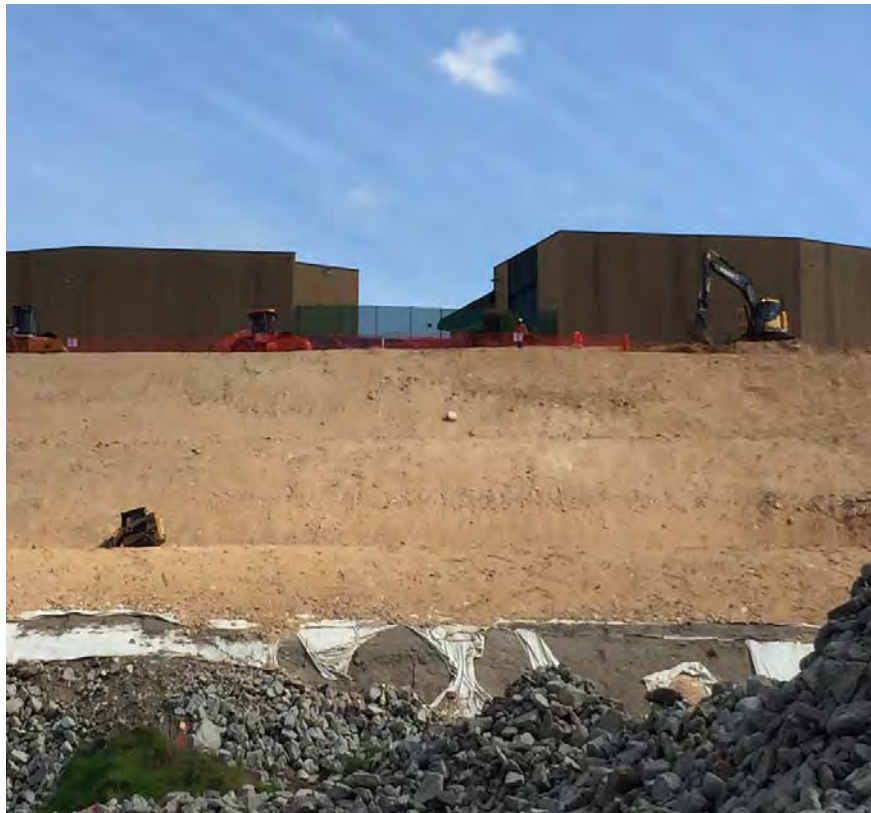
Landslip stabilisation works – earthworks complete
