# **MATAVAI**

## **3 PHILLIP STREET, WATERLOO**

### **STRUCTURAL CONDITION REPORT**

**Report No. DD1375M**

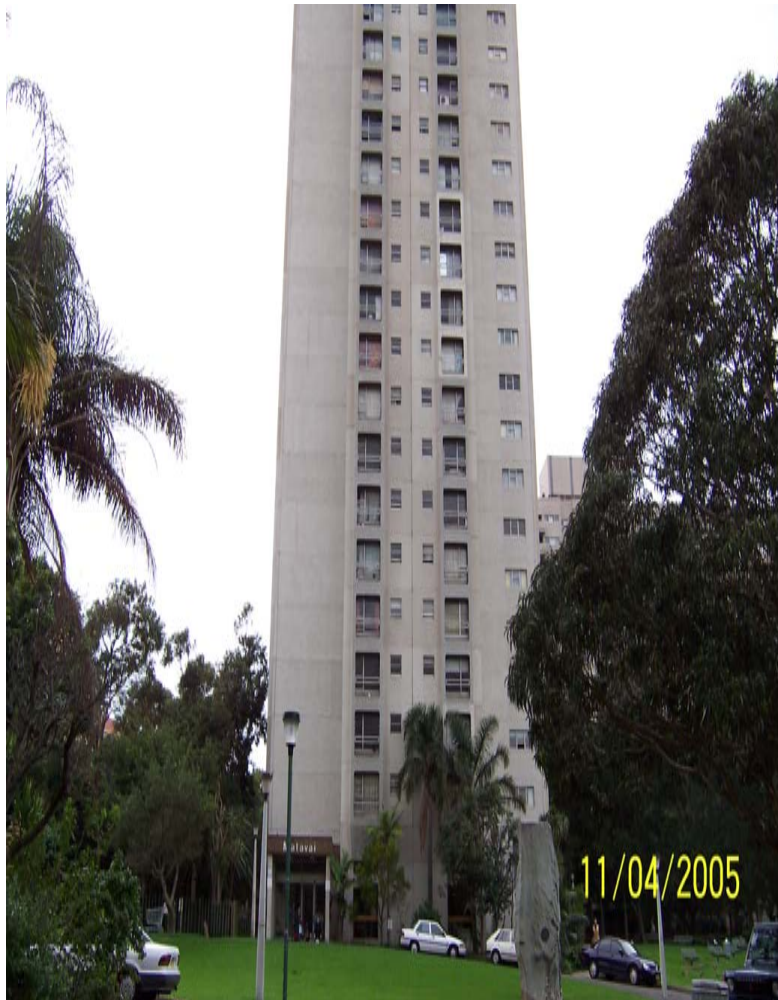
100\_2114.jpg

Level 29 (Internal)	Set ceiling in community room damaged by rain entry.  Remove and replace ASAP	2103, 2104
External facades	Atmospheric pollutants to concrete surfaces. Clean and realkalise all external concrete surfaces and coat with water and pollution repelling protective coating within five years.	2114, 15, 16, 17, 18, 19, 20, 21, 23, 24
External facades	Vertical joints between panels. Replace within ten years.	6933, 34, 36, 37
External facades	Surface pitting & corrosion of aluminium railing in front of windows. Replace within ten years.	2109, 94
External facades	Crack in north east edge of bottom window relief.	005-Appendix C (GBGA0246)

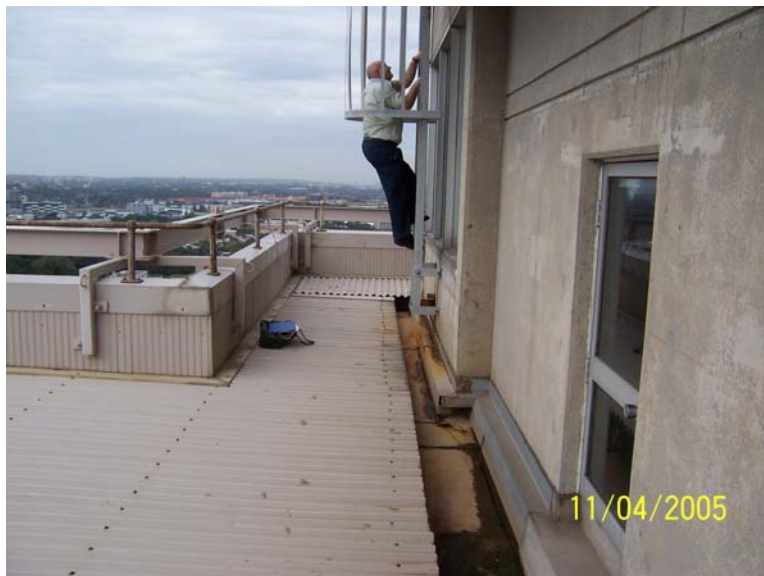
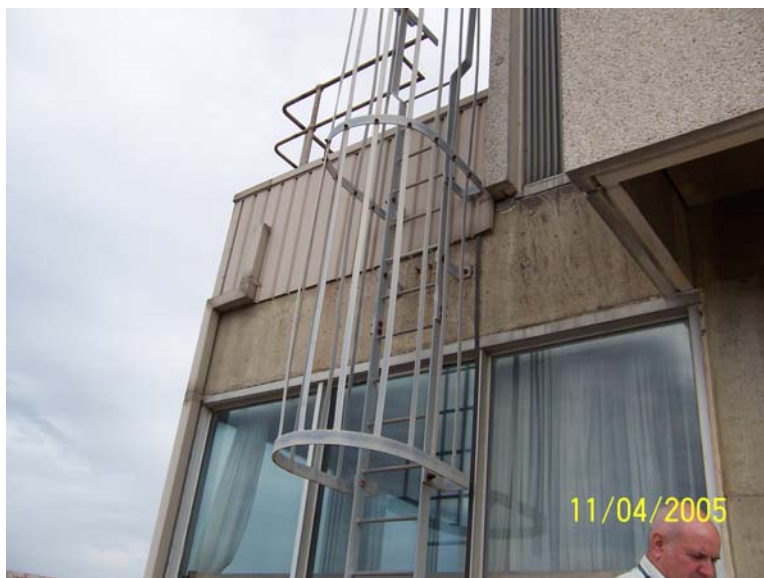
Roof Level – Ladder to upper level	Rusting bolts between steel members and between steel and concrete wall. Replace bolts within 3 years.	2076, 2078

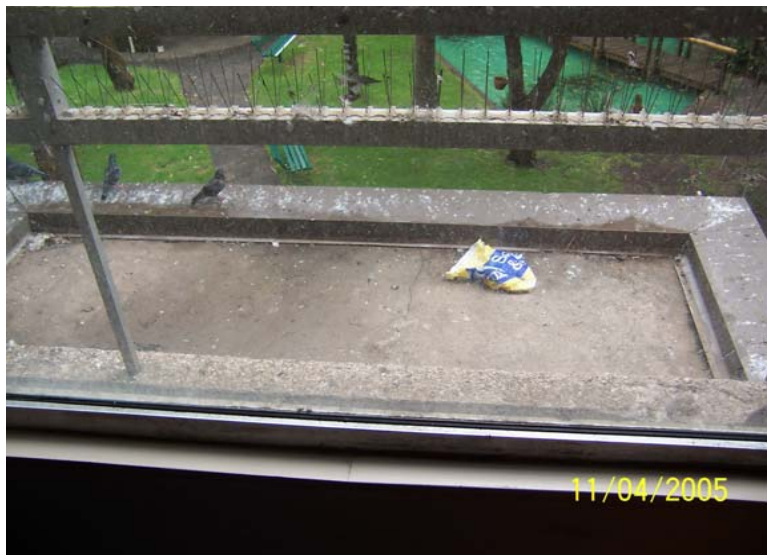
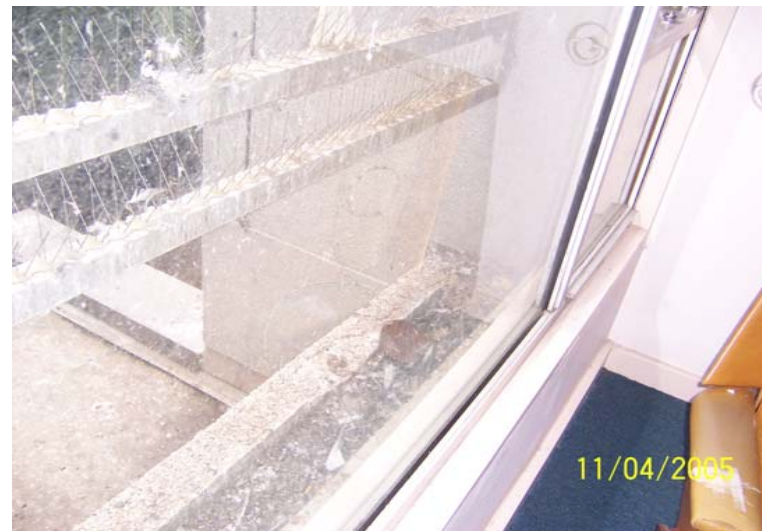
LOCATION	DETAIL	PHOTO REFERENCE
Level 6 – Unit 1 (Internal)	Duct in Bathroom & part bedroom contains asbestos. Remove and replace all ducts (all levels, all units) within 5 years. Vinyl floor tile in Bed sitting room including kitchen contain asbestos. Remove floor tiles and replace within five years (all levels, all units).	2080, 81, 82, 83
Level 6 – Railing (External)	External aluminium railing in front of community room (fixed to wall with stainless bolts) showing sign of surface pitting and corrosion.  Remove and replace all external railing with stainless framing and bolts within ten years.	2091, 94
Level 1 – Concrete roof (External)	Concrete roof over lobby / entry (in front of Community room) developed concrete spalling and shrinkage cracks, photos taken from community room.  Clean concrete roof and repair spalling and coat with water and pollution repelling protective coating within one year.	2108, 2109

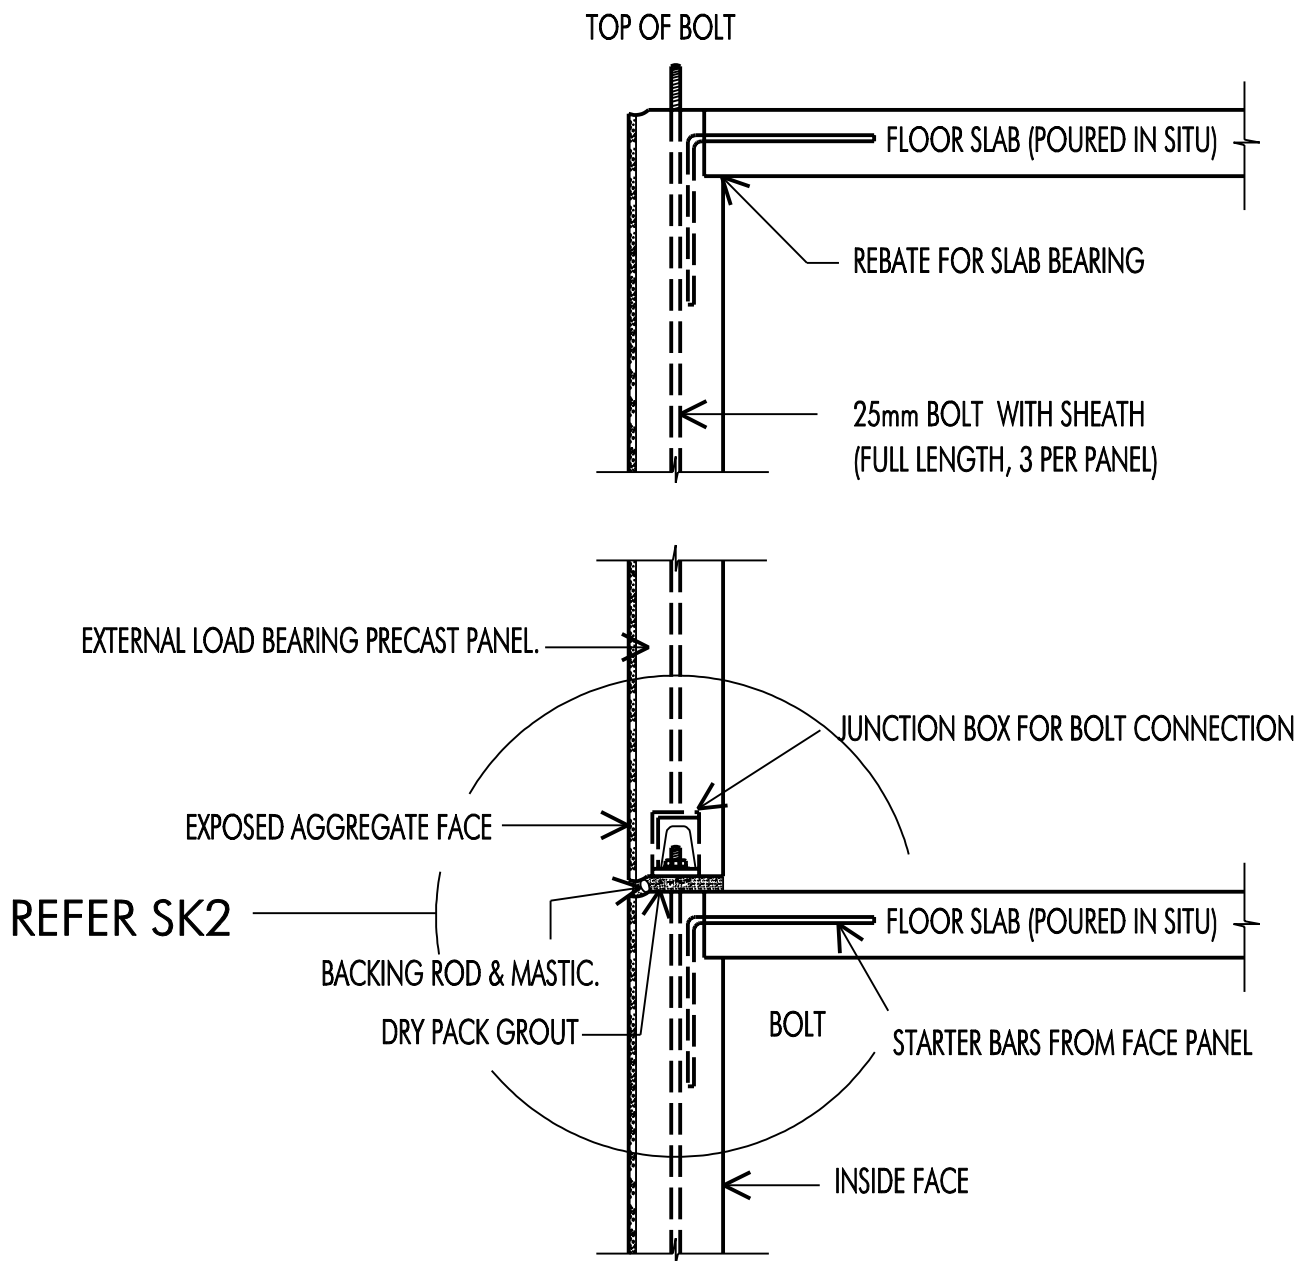
## TYPICAL SECTION THROUGH WALL/FLOOR (SK1)

Besides the summarised defects it is important to note that the external wall structure being load-bearing, an instability in one wall panel due to an accident (such as the blowing out of a wall panel due to explosion in a gas cylinder) can lead to a major collapse of the walls and floor slabs above the destabilised panel (refer sketches SK1, SK2 & SK3 in Appendix B for typical precast panel connection details).

It is recommended that the Department of Housing undertake a review of restraint requirements in the external load-bearing precast panel walls under current Australian Standards.

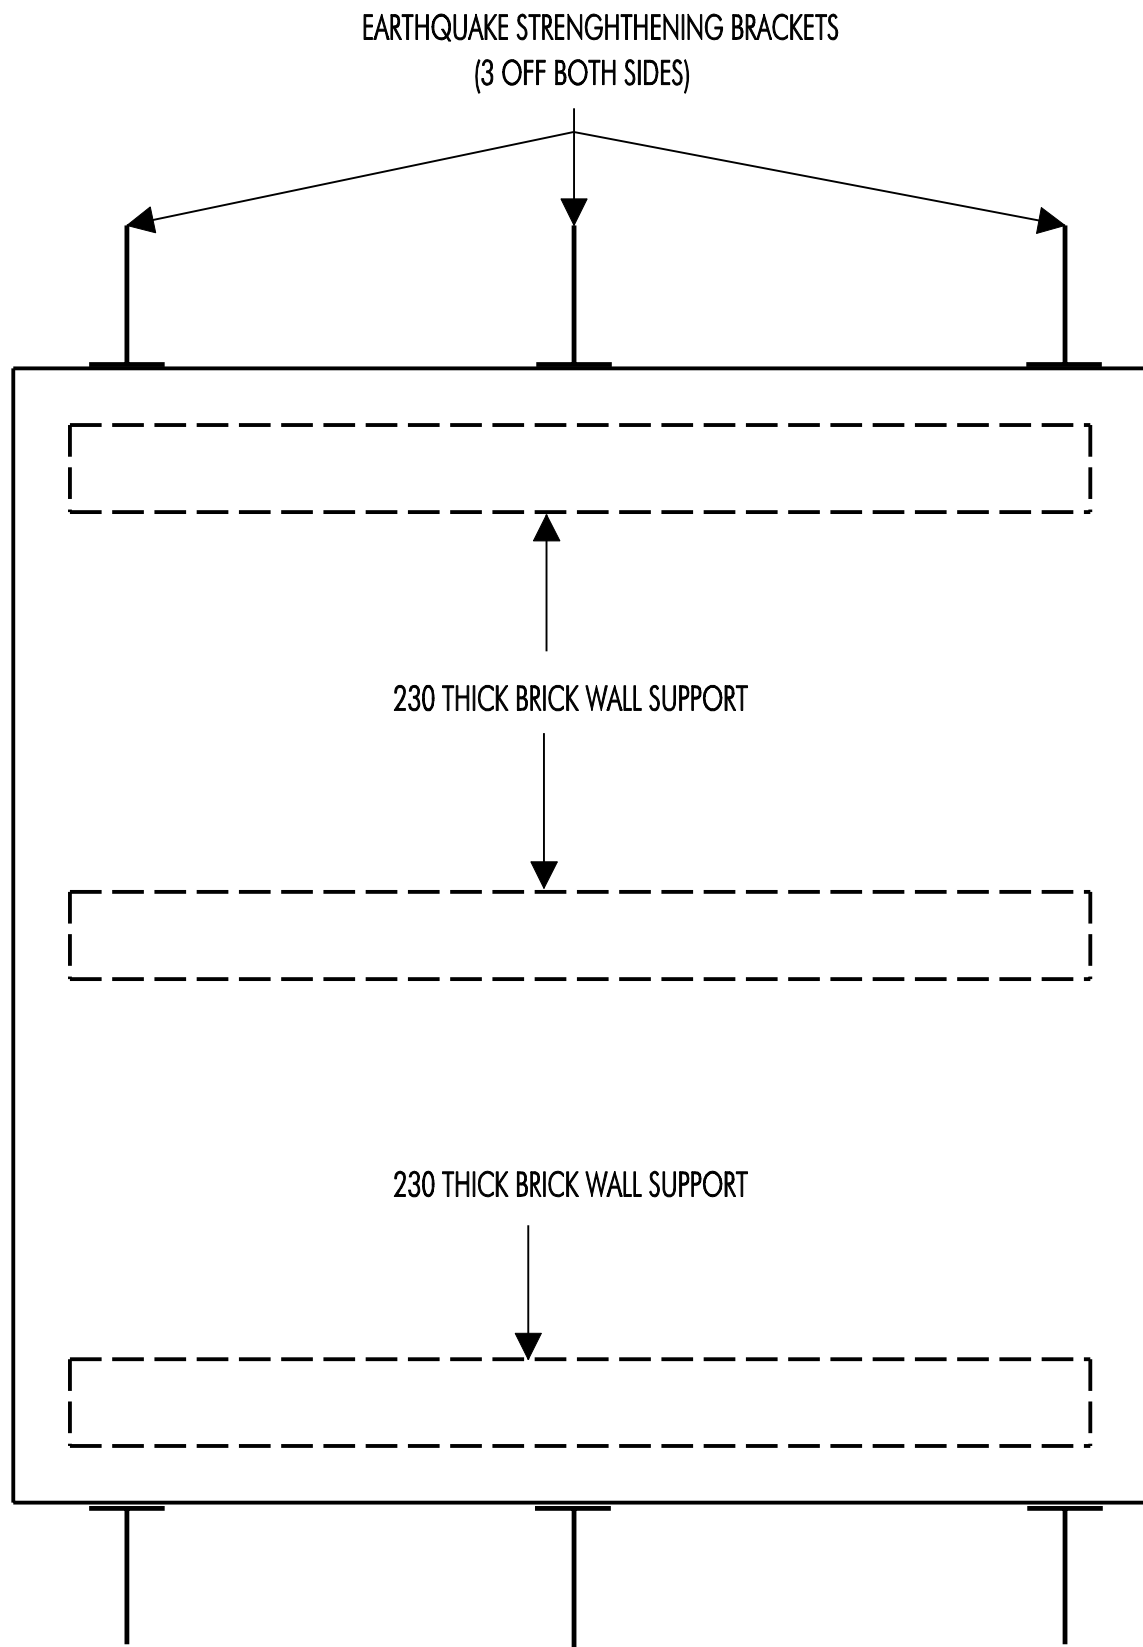
## WATER TANK PLAN (SK4)

The existing water tanks above level 29 are unstable under earthquake forces and they are recommended to be stabilised. Refer to Appendix B for schematic layout and strengthening details for the existing water tanks (SK4, SK5, SK6).
