COMMON FAILURE POINTS FOR THE 15 KVA 400HZ GENERATOR

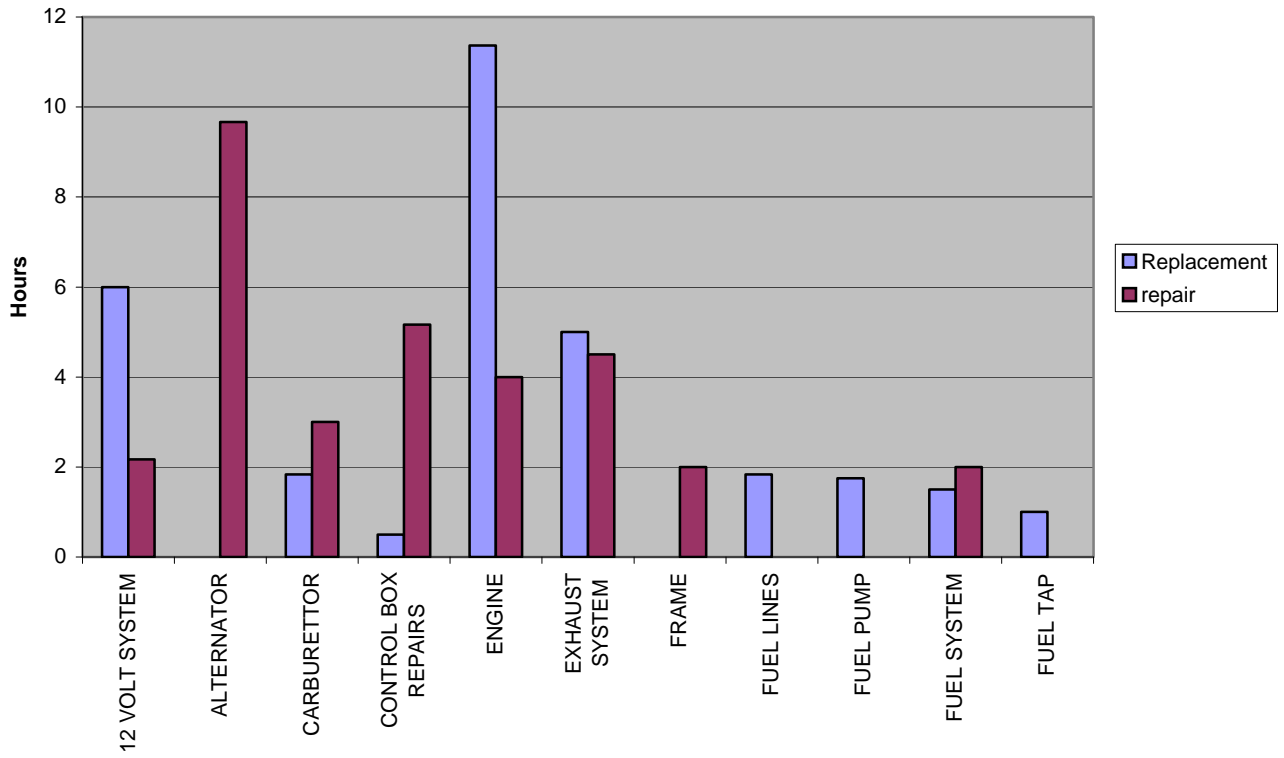
Replacement vs Repair Times (avg) Chart 1

The above tables show the average life expectancy for components on the generators. Charts 1 and 2 show the average time between repairs to components compared to the time to repair them. Charts 3 and 4 shows the average time between failures of parts and the projected part usage.

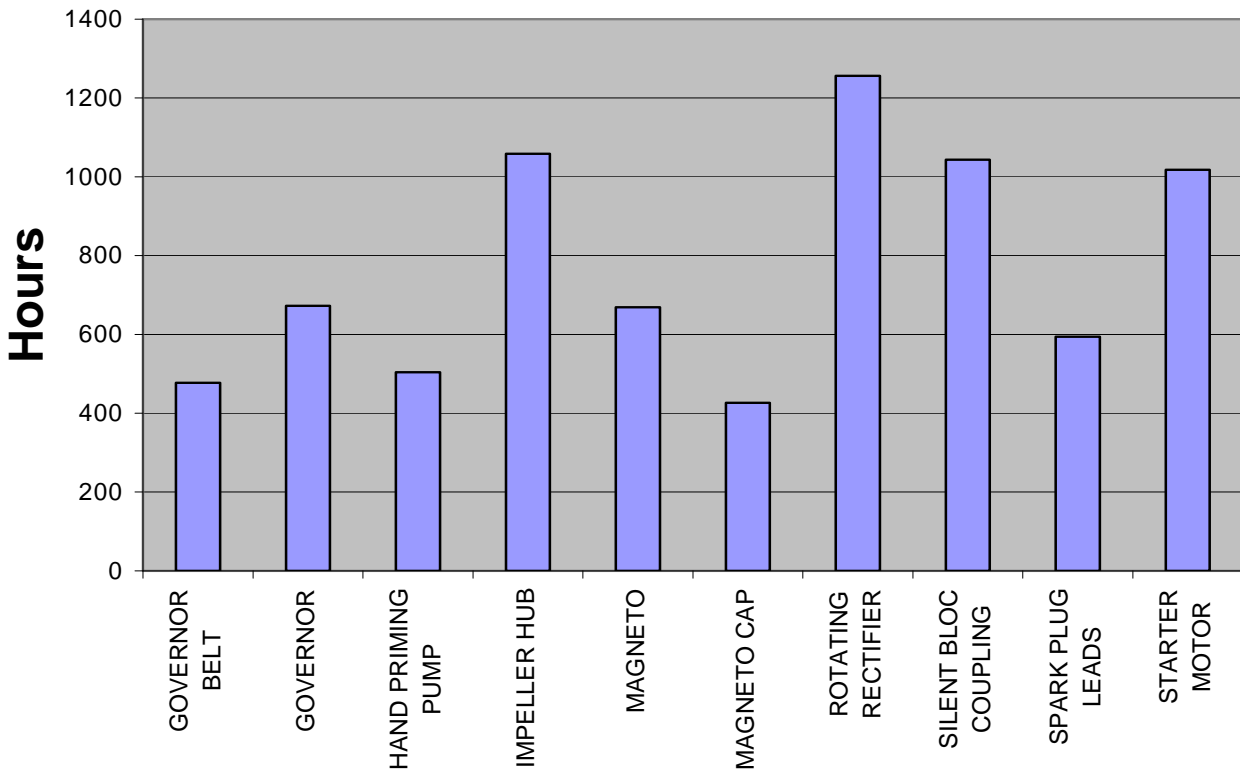
Hours Before Repair or Replacement (avg) chart 4

The average life for the magnetos is about 600 hours ref Chart 4
