**RADIOLOGICAL SURVEY REPORT -
CSIRO RADIATION WASTE STORE, WOOMERA, SOUTH
AUSTRALIA**

Technical Report (Version 1)
October 2008

This report details the radiological assessment and inspection of the CSIRO Radiation Waste Store at Woomera. It has been prepared by the Health Physics Section (HPS) at the request of ARPANSA's Regulatory and Policy Branch (RPB).

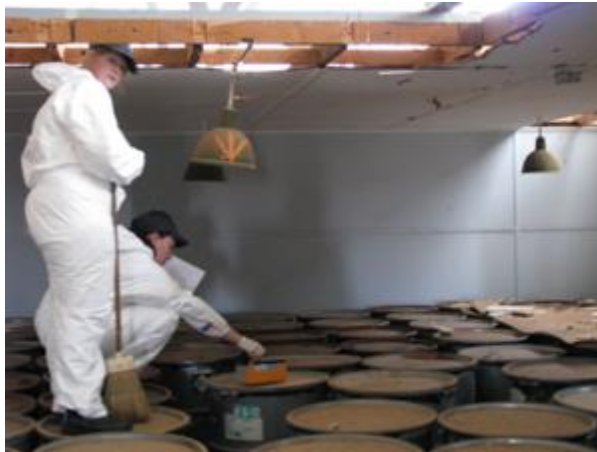
Photo 2: (a) a drum is marked with an orange arrow above, and (b) the drum lid is marked with an orange circle.

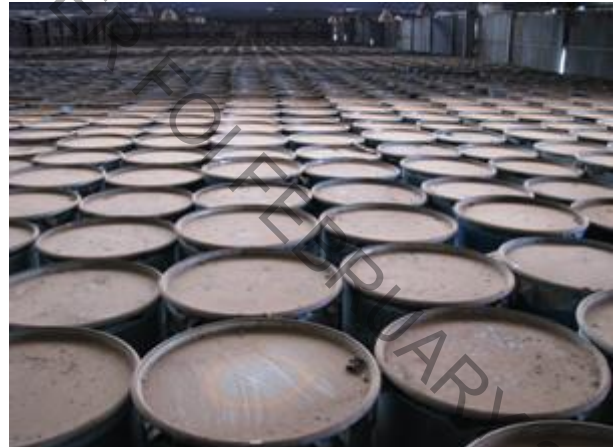
(b)

The results of the radon-222 survey are shown in Table 2. Results are an average concentration of radon-222 levels measured over 15 minutes. Levels ranged from 24 to 94 Bq/m³. The highest radon level of 94 Bq/m³ was measured next to an ajar lid of drum 3613 indicating the possible leakage of radon-222.

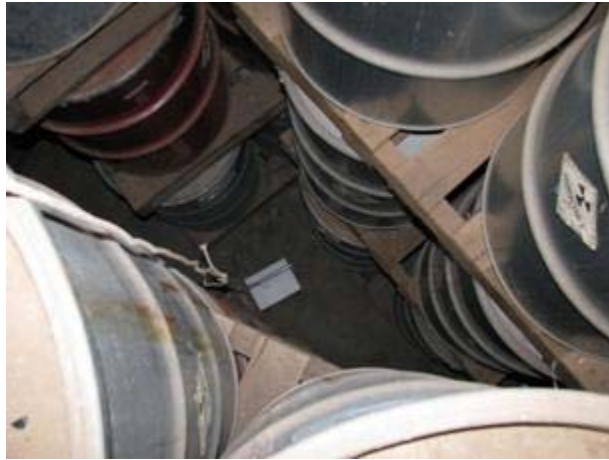
Photo 3: The SARAD radon monitor was lowered into a gap in the drums to measure the radon concentration at ground level.

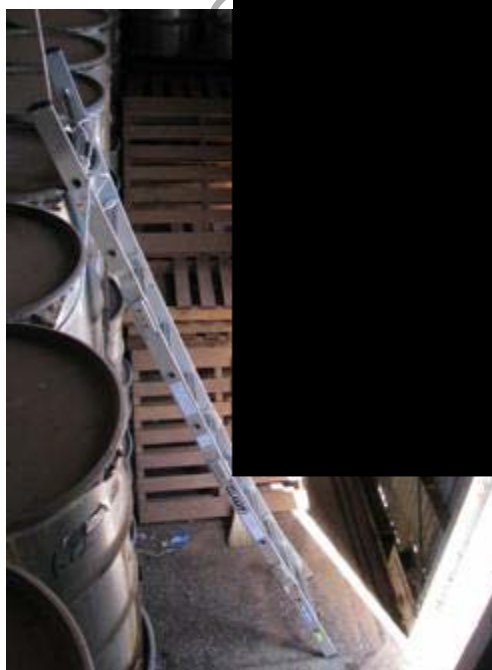
Photo 4: A ladder just inside the entrance was used to access the top of the drums. The crate-stairs are also shown.
