## **Miepol Pty Ltd**

### **TWO BUS STOPS ON TOWNSEND STREET, WHITTINGTON**

#### **Existing Condition Road Safety Audit Rev A**

#### **HDS Australia Pty Ltd**

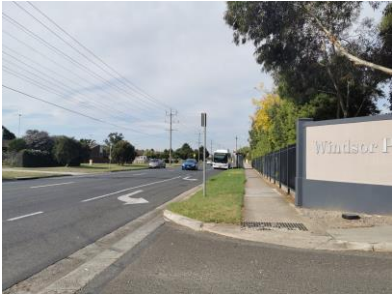
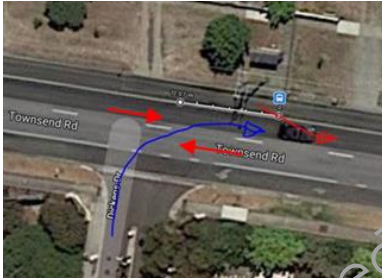
Item	Audit Findings	Recommendations	Risk Level	Project Manager	
				Accept Yes/No	Responses
1	<p>When a bus is stationary at bus stop ID 50722 the sight lines for vehicles exiting Dickens Drive to turn either left or right is not acceptable (about 55m) for the speed environment.</p>

<p>It should be noted that there is a bus stop (ID 30632) on the northern side of Townsend Road also which exacerbates the situation for vehicles wishing to turn right out of Dickens Drive, should there be a bus at both stops (30632 and 50722). This situation would require the driver exiting to turn right from Dickens Drive to consider three potential points of conflict simultaneously, i.e. (i) the westbound traffic, (ii) eastbound traffic and the (iii) bus on the northern side of Townsend Road departing and merging. This level of complexity could overwhelm the driver exiting Dickens Drive to perform an ill-considered and unsafe manoeuvre, which may lead to either a side impact or rear-end crash.</p>

<p>Consider changing to left turn only on Dickens Drive.</p>	Medium

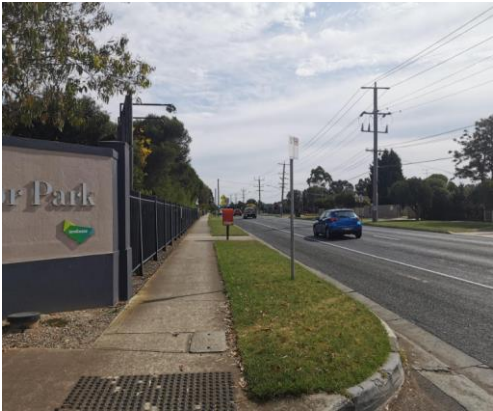
Item	Audit Findings	Recommendations	Risk Level	Project Manager	
				Accept Yes/No	Responses
2	<p>The bus zone on the southern side of Townsend Road and west of Dickens Drive is still signposted. This bus zone has an Australia Post box located within it also.</p>

<p>If this bus zone is now redundant, consider removing this bus zone.</p>	Low

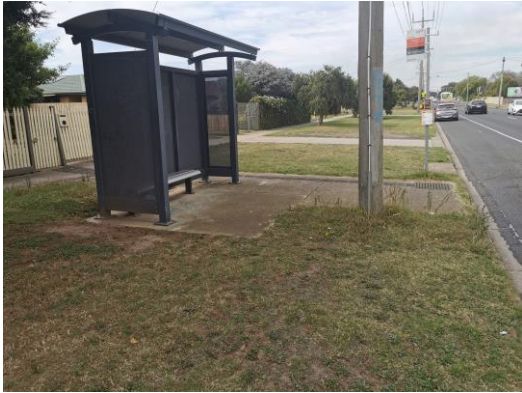
Item	Audit Findings	Recommendations	Risk Level	Project Manager	
				Accept Yes/No	Responses
3	<p>Tactile indicators for the visually impaired are a dark grey and should be more visible e.g., bright yellow as per current DDA requirements.</p>

Consider replacing tactile indicators.	Low

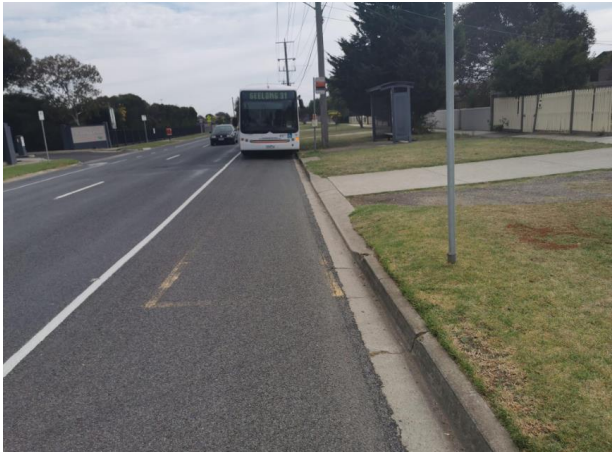
Item	Audit Findings	Recommendations	Risk Level	Project Manager	
				Accept Yes/No	Responses
4	<p>Yellow bus bay linemarking is faded.</p>

<p>Consider remarking both bus zones to coincide with the bus zone signposting.</p>	<p><b>Comment</b></p>

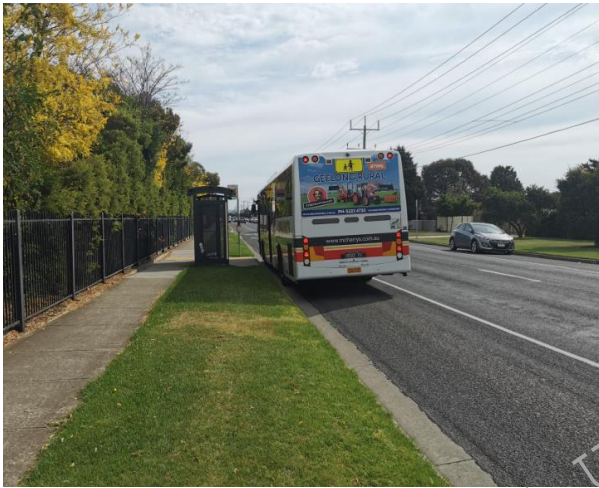
Item	Audit Findings	Recommendations	Risk Level	Project Manager	
				Accept Yes/No	Responses
5	<p>The BUS ZONE (R) sign on the approach side of the bus stop (ID 50722) is missing therefore making the bus zone nonconforming.</p>

<p>Install a BUS ZONE (R) sign on the approach to the bus stop to clearly define the limits of the bus zone.</p>	Comment
