FMG Ref: 273632 - S44580

15 October 2021

Re: Inspection of land at 42 James Street, NORTHCOTE, VIC 3070

ENGINEERING	CLIENT City of Darebin	DESIGNED	DRAWN	SM	
		PROJECT TITLE Stabilisation of Existing Batter	CHECKED	No. OF SHEETS	1 of 3	
		SITE ADDRESS 42 James Street, Northcote, VIC 3070	SCALE NTS @ A4	DATE STARTED	22/04/2021	
		DRAWING TITLE Option 1 - Installation of a Permanent Batter	SITE ID & JOB No. S44580 - 273632	REV.	0	
		DRAWING No.	SK01

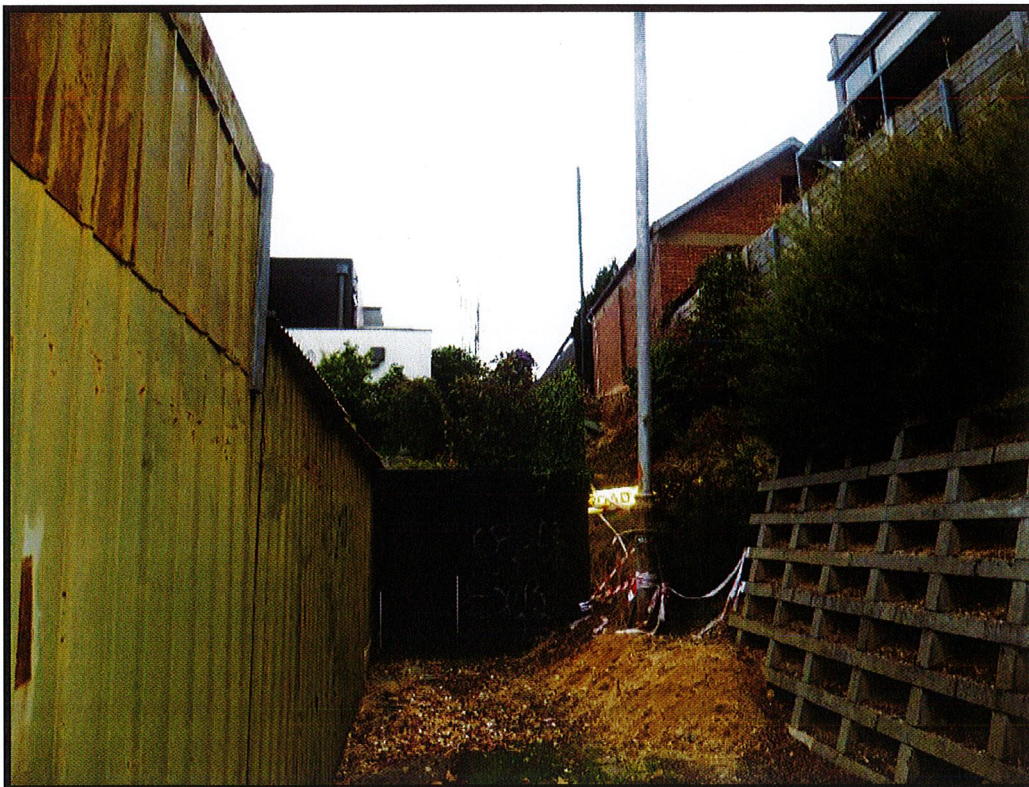
Photograph 2 – Photograph captured 29 April 2019. View of eastern end of subject land, looking west. Note spoil / loose material in laneway at the bottom of the batter.

- Significant vegetation growth has occurred between November 2020 and October 2021, hence it was difficult to compare all areas of the subject land.
- It is unclear as to whether erosion of the steep slope to the eastern end of the subject land, directly adjacent to the existing concrete crib retaining wall has occurred between November 2020 and October 2021 [5 – 6]. However localised erosion of the land has occurred since April 2019 [2 – 6].

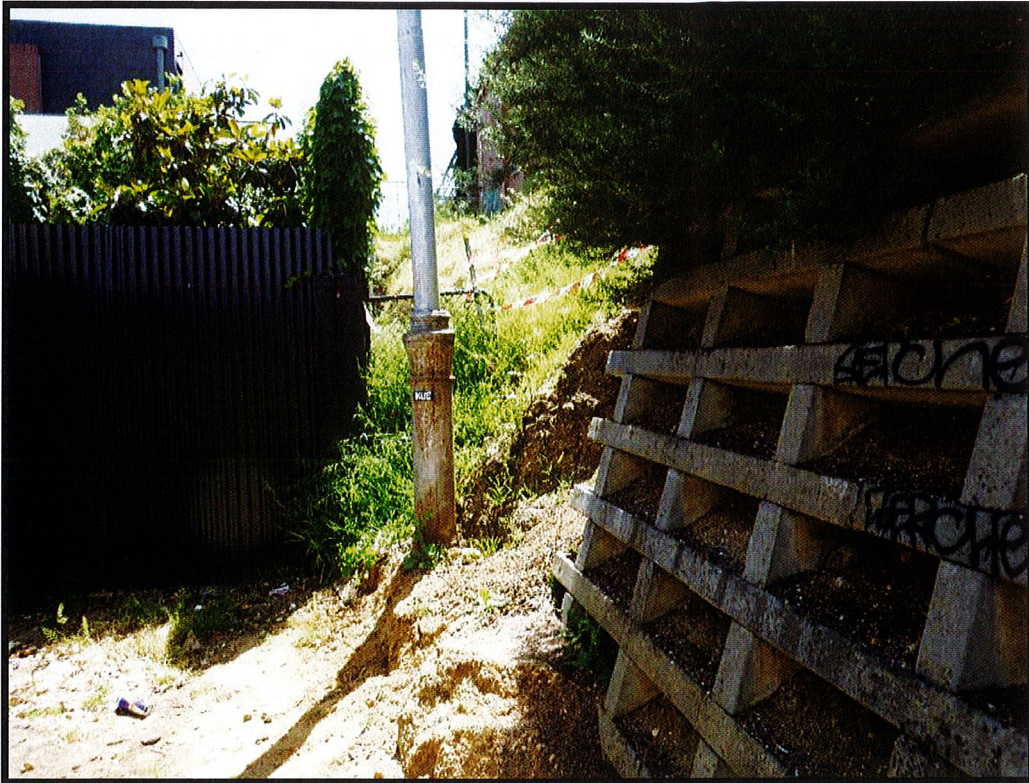
Photograph 3 – Photograph captured 19 November 2020. View of eastern end of subject land, looking west. Note spoil / loose material in laneway at the bottom of the batter. Slight erosion of material when compared to April 2019 (photograph 2).

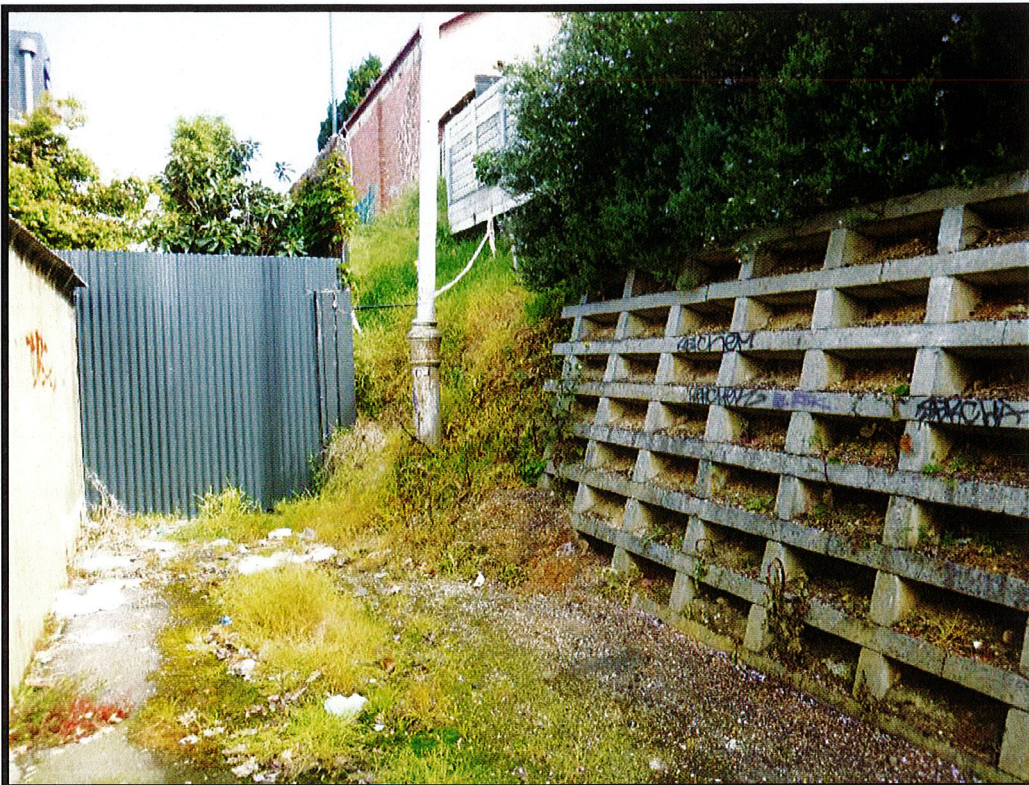
Photograph 4 – Photograph captured 13 October 2021. View of eastern end of subject land, looking north. Note spoil / loose material in laneway at the bottom of the batter, with vegetation growth over.

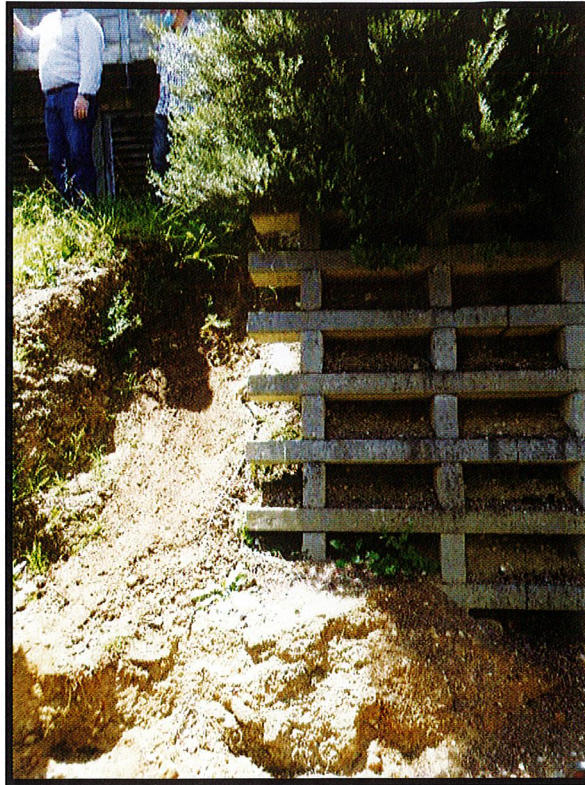
Photograph 5 – Photograph captured 19 November 2020. View of the eastern end of the subject land, looking north. Note localised erosion of land resulting in steep slope adjacent to crib wall.

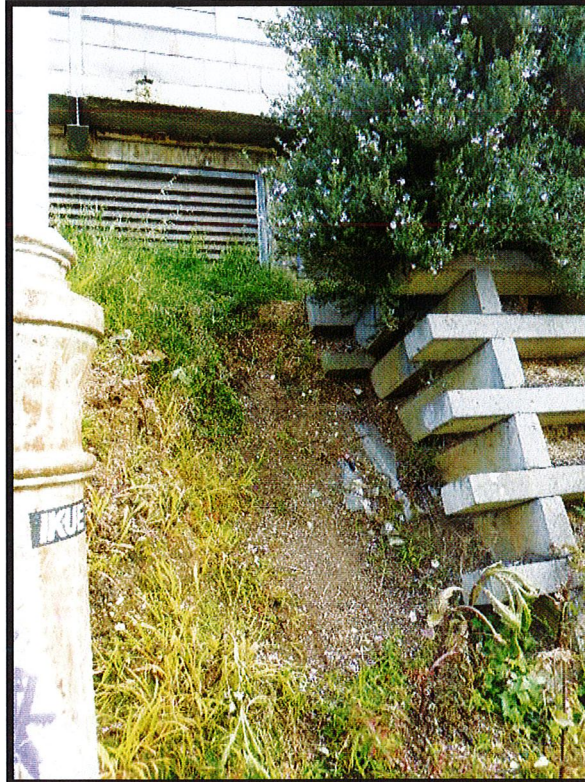
Photograph 6 – Photograph captured 14 October 2021. View of the eastern end of the subject land, looking north. Note localised erosion of land resulting in steep slope adjacent to crib wall.

As outlined above, it is FMG's opinion that localised erosion of the ground to the eastern and western ends of the subject land has occurred between November 2020 and October 2021. Whilst FMG did not observe any evidence that there is a risk of an imminent collapse of the subject land, FMG recommends that the City of Darebin undertake remediation works to the land as soon as practically possible to ensure that further deterioration of the land does not occur, which may result in a destabilisation of the land and potential localised collapse of the land and damage to the adjoining properties.

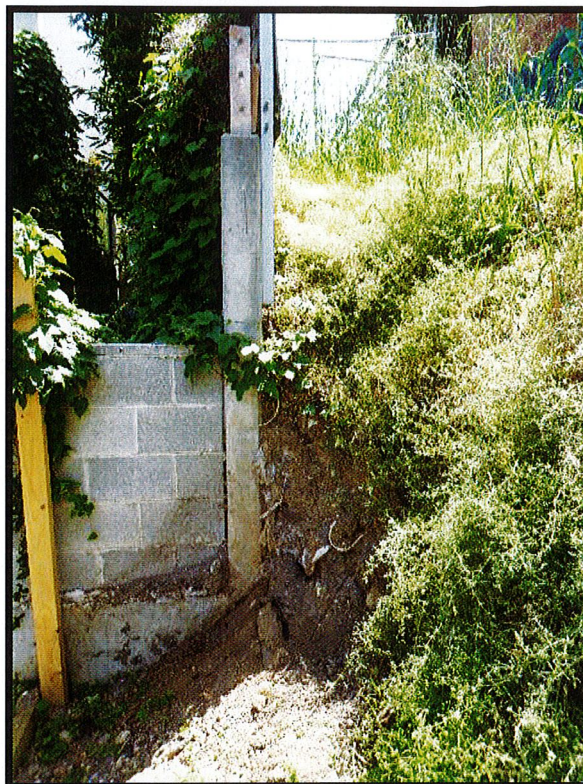
Photograph 7 – Photograph captured 19 November 2020. View of the western end of the subject land, looking west, at the north-east corner of 1 Campbell Grove (north-east corner of 1A Campbell Grove). Note vertical face of earth adjacent to concrete retaining wall.

- Erosion of the ground has occurred between November 2020 and October 2021, to the western end of the subject land, adjacent to the concrete retaining wall at the north-west corner of 1 Campbell Grove, Northcote (retaining wall located at the north-east corner of 1A Campbell Grove, Northcote) [7 – 12].

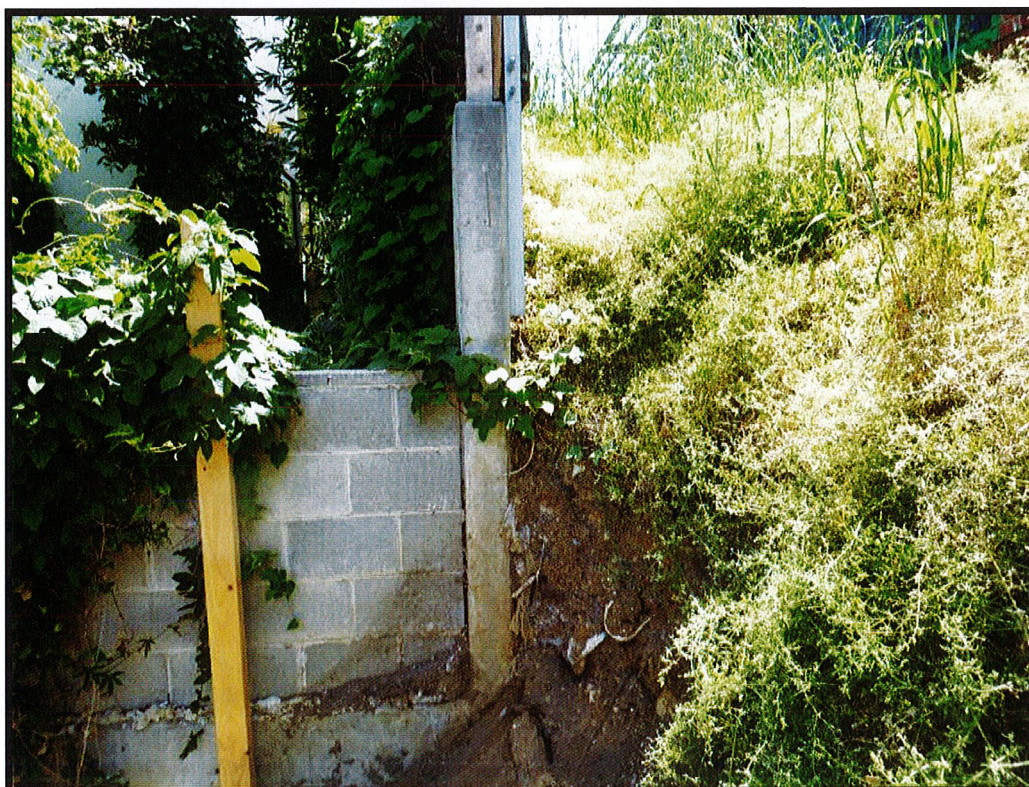
Photograph 8 – Photograph captured 19 November 2020. View of the western end of the subject land, looking west, at the north-east corner of 1 Campbell Grove (north-east corner of 1A Campbell Grove). Note vertical face of earth adjacent to concrete retaining wall.

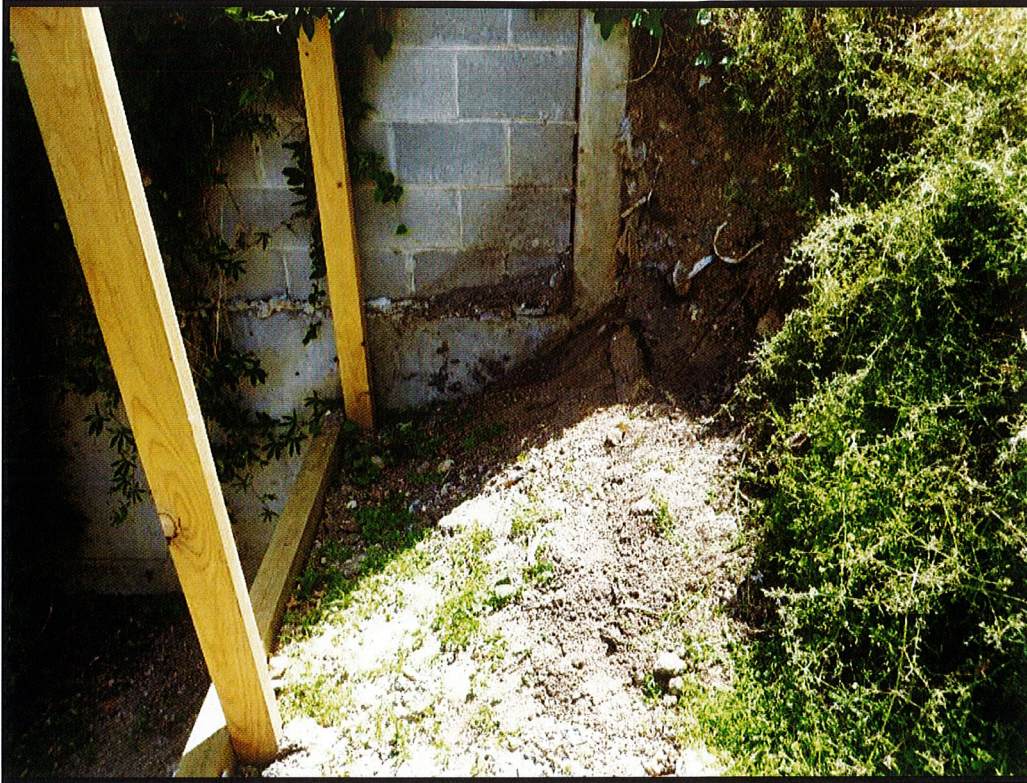
Photograph 9 – Photograph captured 19 November 2020. View of the western end of the subject land, looking west, at the north-east corner of 1 Campbell Grove (north-east corner of 1A Campbell Grove). Note vertical face of earth adjacent to concrete retaining wall.

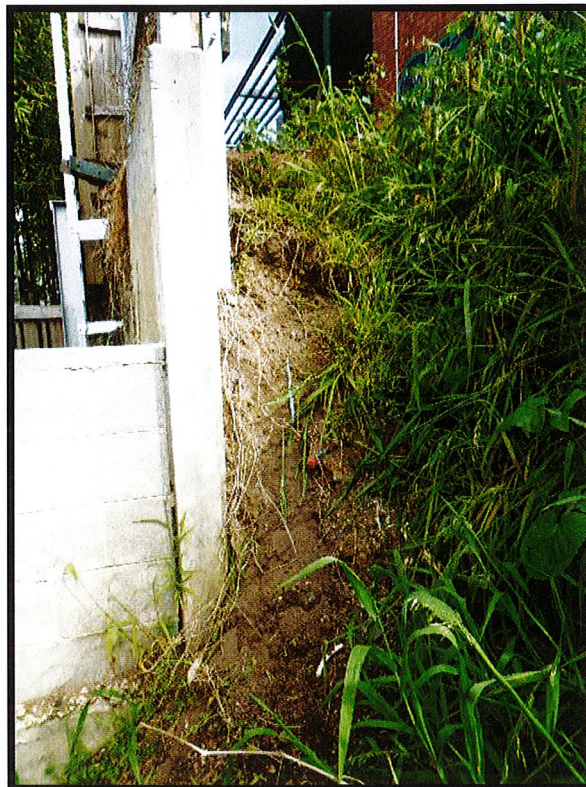
Photograph 10 – Photograph captured 13 October 2021. View of the western end of the subject land, looking west, at the north-east corner of 1 Campbell Grove (north-east corner of 1A Campbell Grove). Erosion of ground adjacent to retaining wall evident compared to November 2020 (photographs 7 – 9).

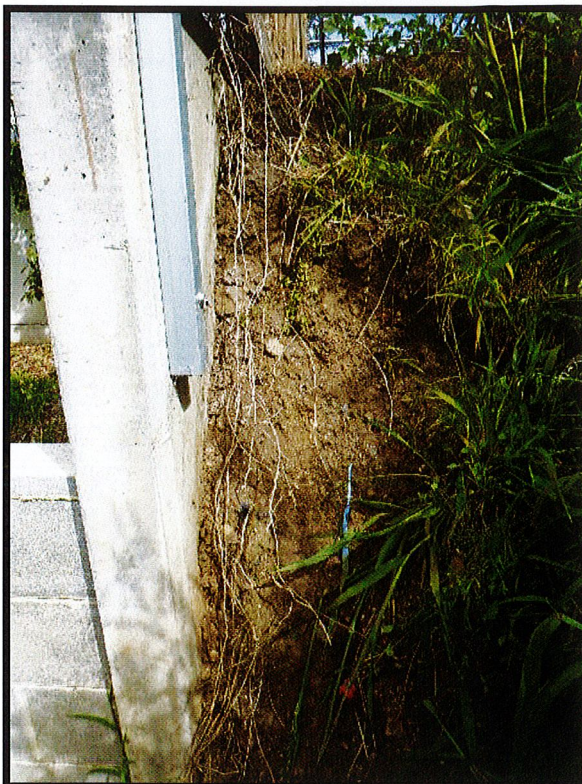
Photograph 11 – Photograph captured 13 October 2021. View of the western end of the subject land, looking west, at the north-east corner of 1 Campbell Grove (north-east corner of 1A Campbell Grove). Erosion of ground adjacent to retaining wall evident compared to November 2020 (photographs 7 – 9).

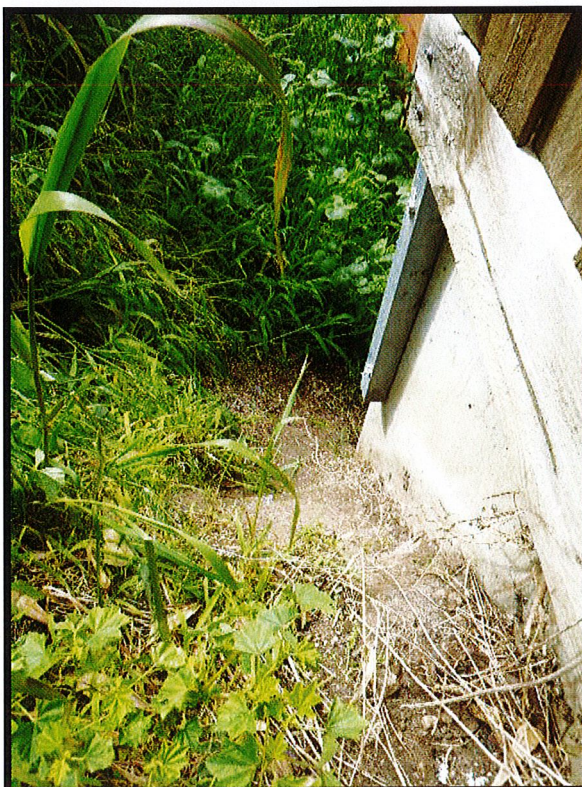
Photograph 12 – Photograph captured 13 October 2021. View of the western end of the subject land, looking east, at the north-east corner of 1 Campbell Grove (north-east corner of 1A Campbell Grove). Erosion of ground adjacent to retaining wall evident compared to November 2020 (photographs 7 – 9).

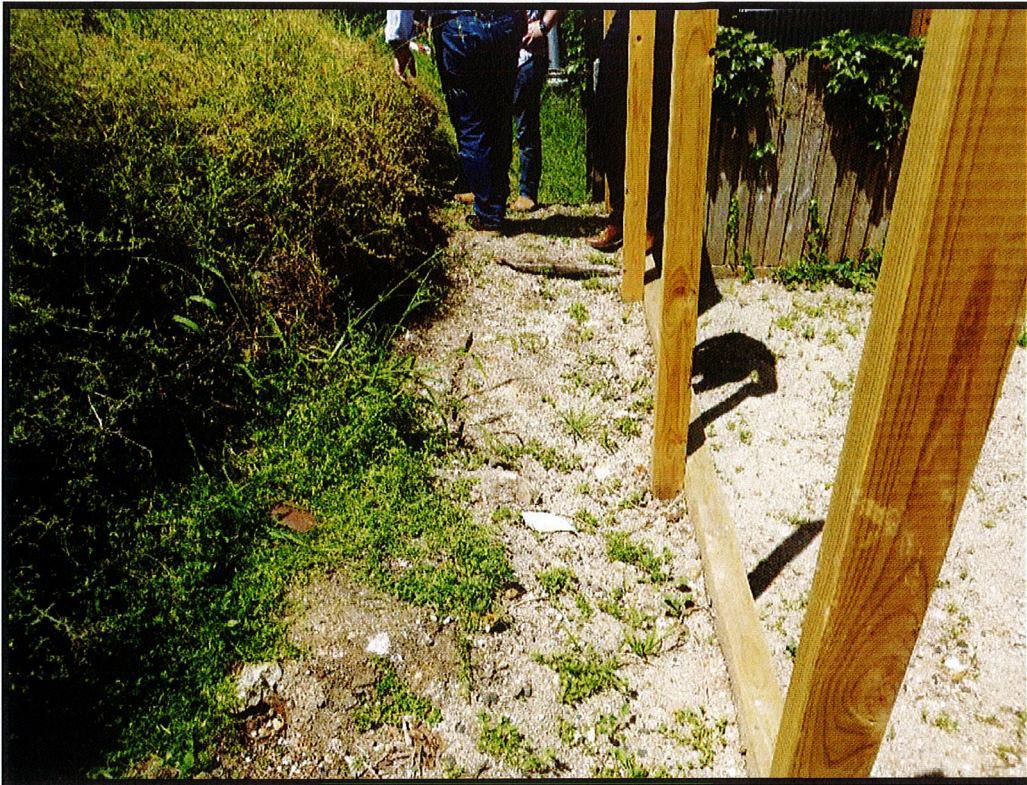
Photograph 13 – Photograph captured 19 November 2020. View along the southern side of the subject land looking east (i.e. long 1 Campbell Grove boundary).

- Erosion / movement of the land along the southern side of the subject land (i.e. adjacent to the northern boundaries of 1 and 3 Campbell Grove, Northcote) does not appear to have occurred. Localised outcrops of rock are currently visible in this area, similar to November 2020, with no evidence of loose / displaced soil at the toe of the rock outcrops [13 – 17].

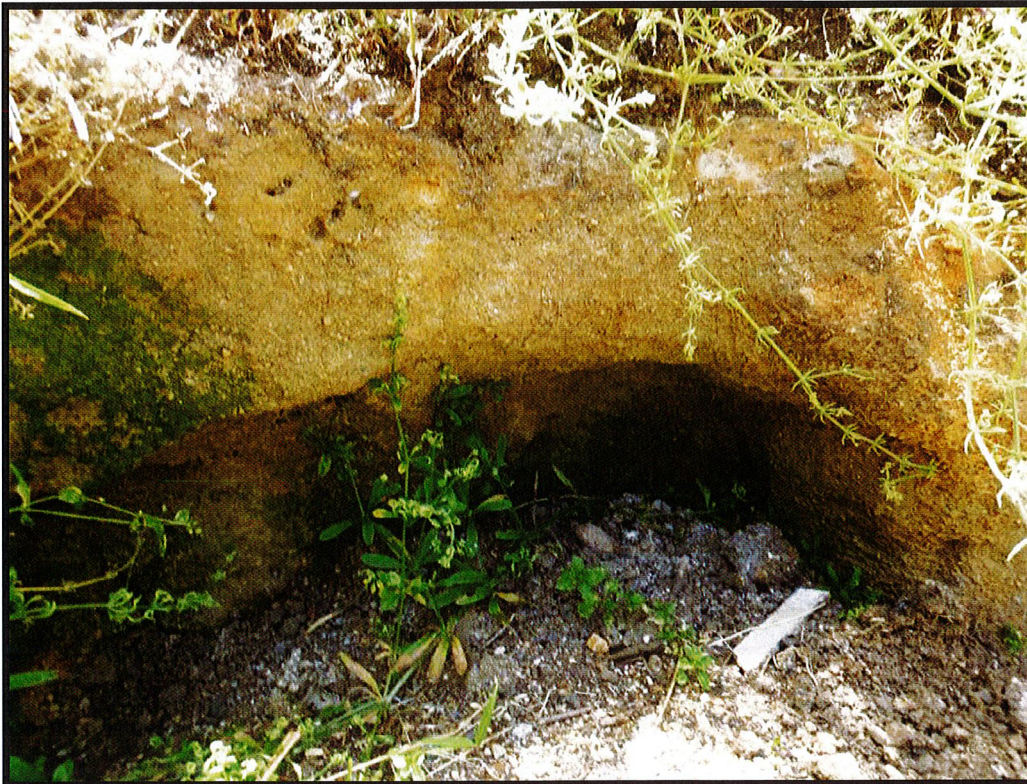
Photograph 14 – Photograph captured 19 November 2020. View of rock outcrop in area shown in photograph 13 above.

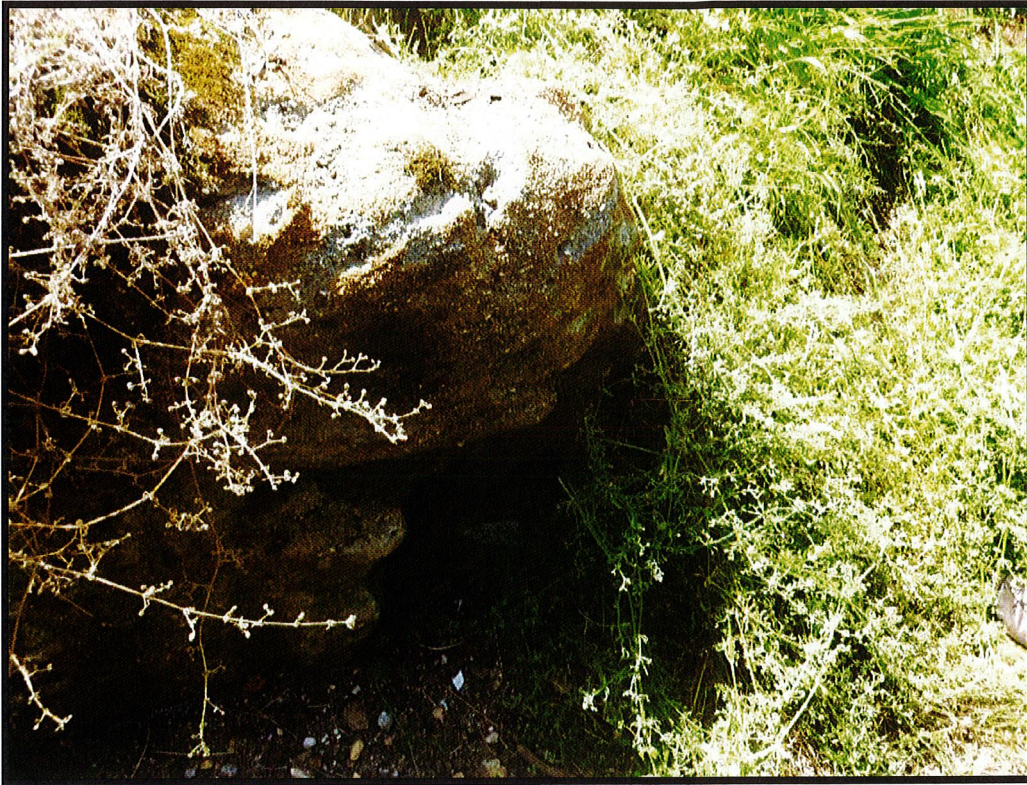
Photograph 15 – Photograph captured 19 November 2020. View of rock outcrop in area shown in photograph 13 above.

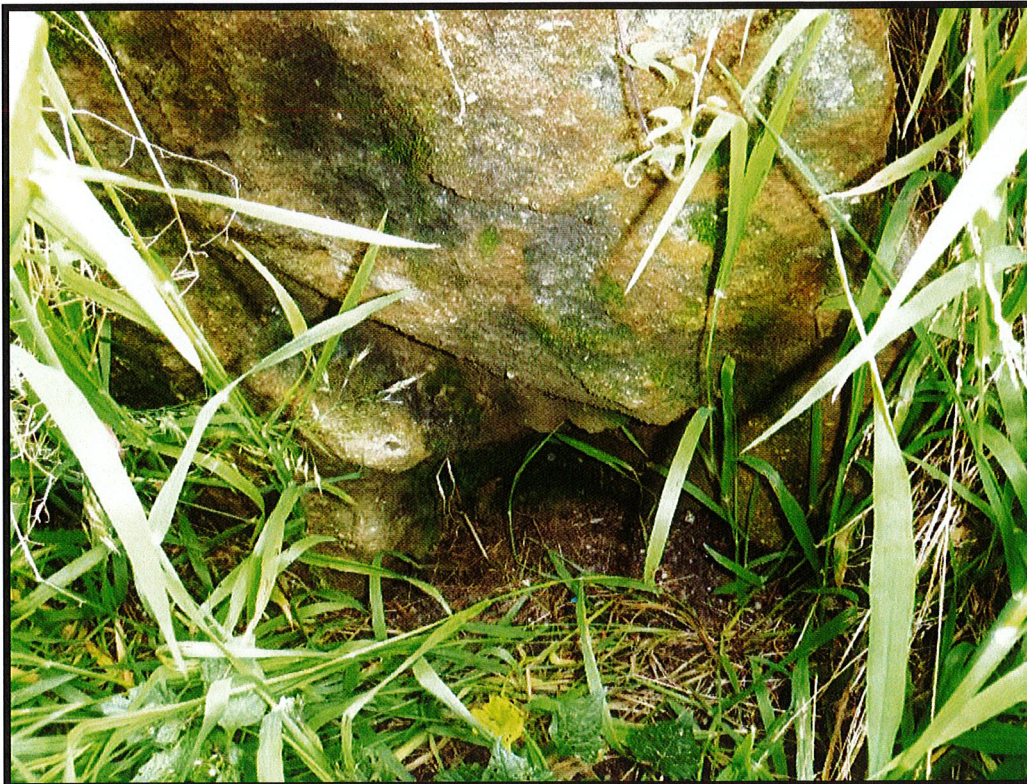
Photograph 16 – Photograph captured 13 October 2021. View of rock outcrop along the southern side of the subject land (i.e. long 1 Campbell Grove boundary). No evidence of loose / displaced soil at the toe of the rock outcrop.

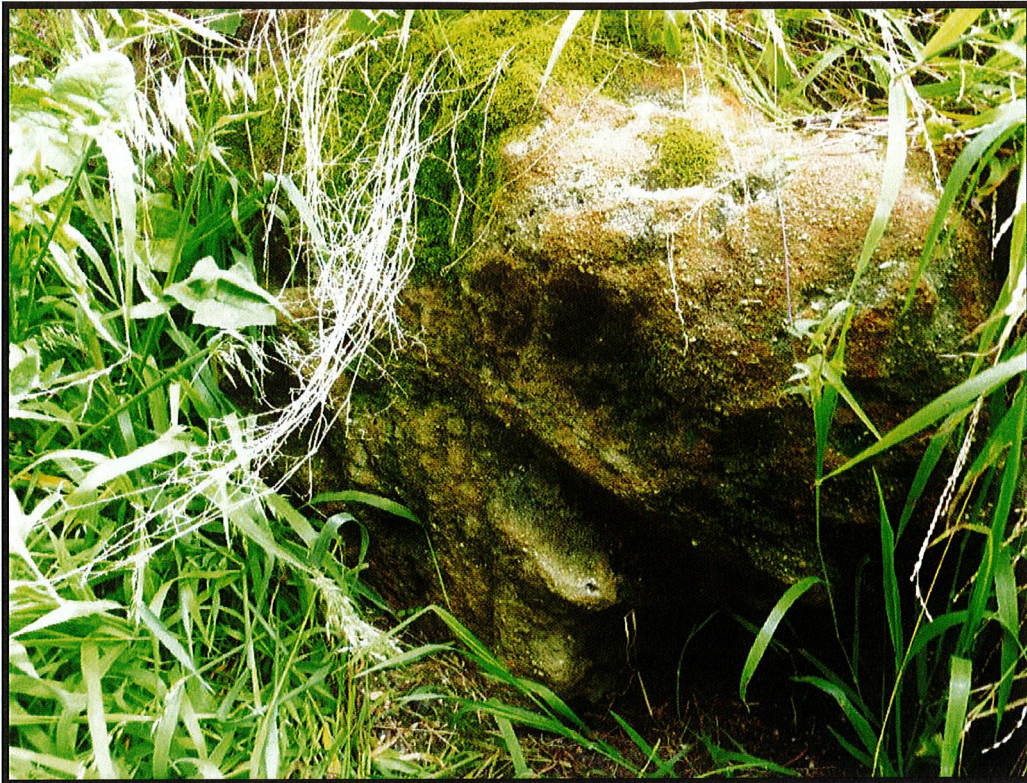
Photograph 17 – Photograph captured 13 October 2021. View of rock outcrop along the southern side of the subject land (i.e. long 1 Campbell Grove boundary). No evidence of loose / displaced soil at the toe of the rock outcrop.

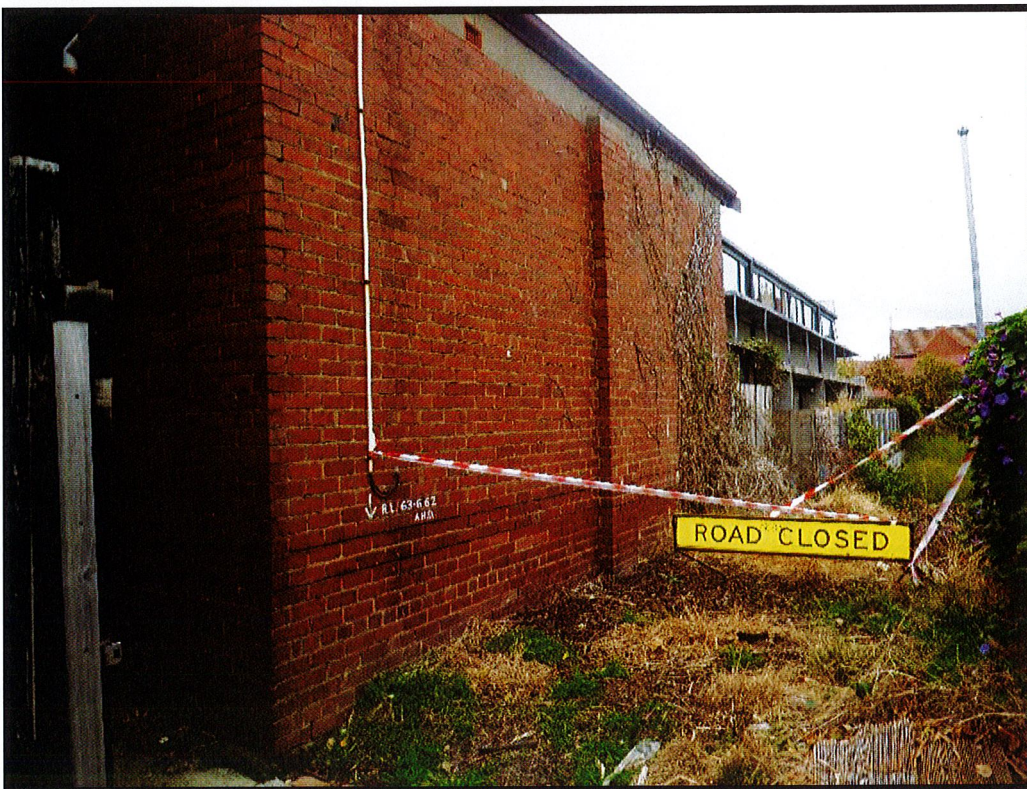
- No evidence of movement and / or damage to the brickwork wall along the south boundary of 42 James Street, at the top of the battered ground to the subject land [18 – 20].

Photograph 18 – Photograph captured 29 April 2019. No evidence of movement and / or damage to the brickwork wall along the south boundary of 42 James Street, at the top of the battered ground to the subject land.

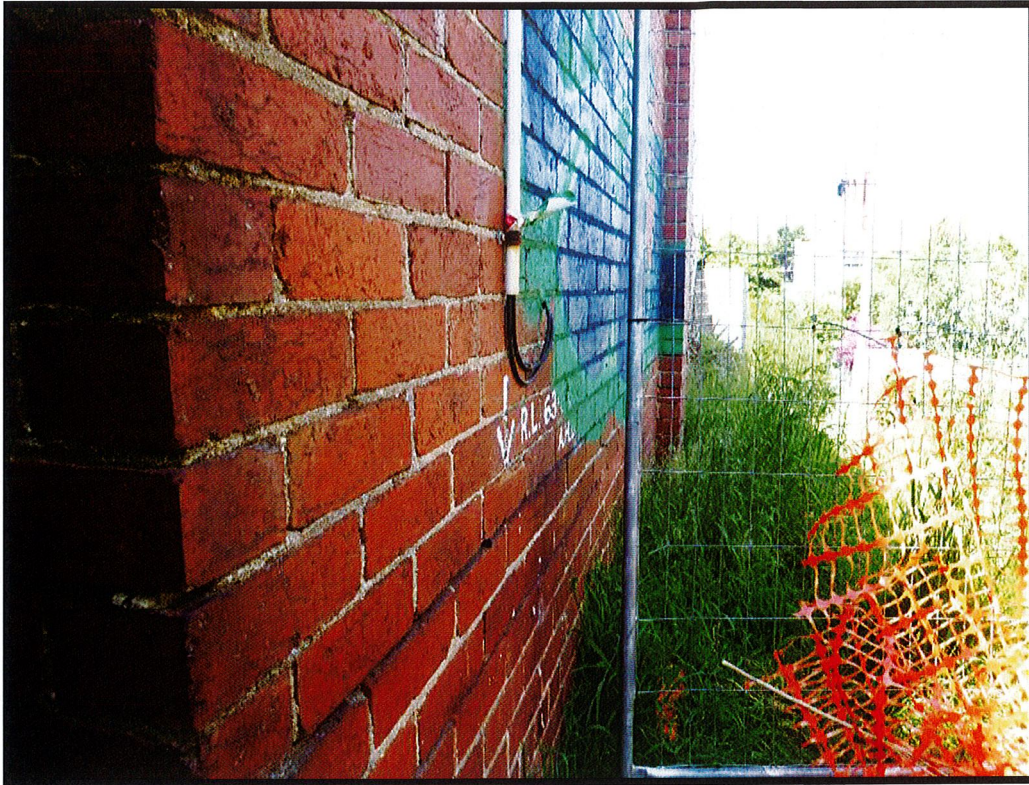
Photograph 19 – Photograph captured 19 November 2020. No evidence of movement and / or damage to the brickwork wall along the south boundary of 42 James Street, at the top of the battered ground to the subject land.

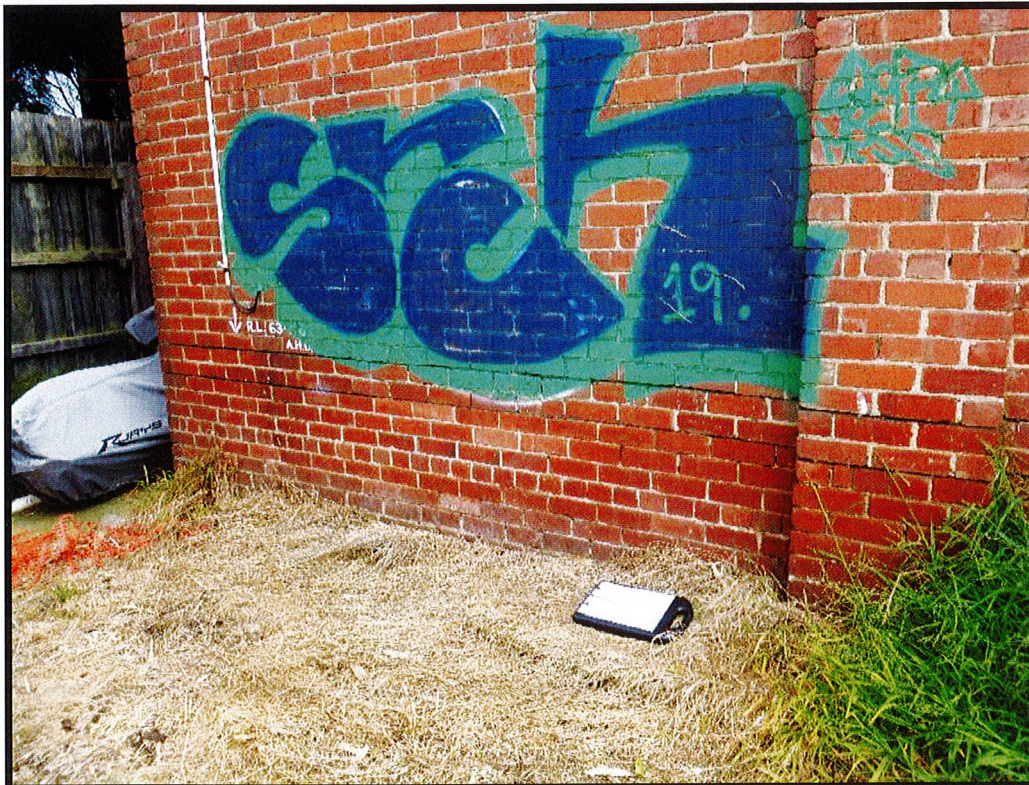
Photograph 20 – Photograph captured 13 October 2021. No evidence of movement and / or damage to the brickwork wall along the south boundary of 42 James Street, at the top of the battered ground to the subject land.

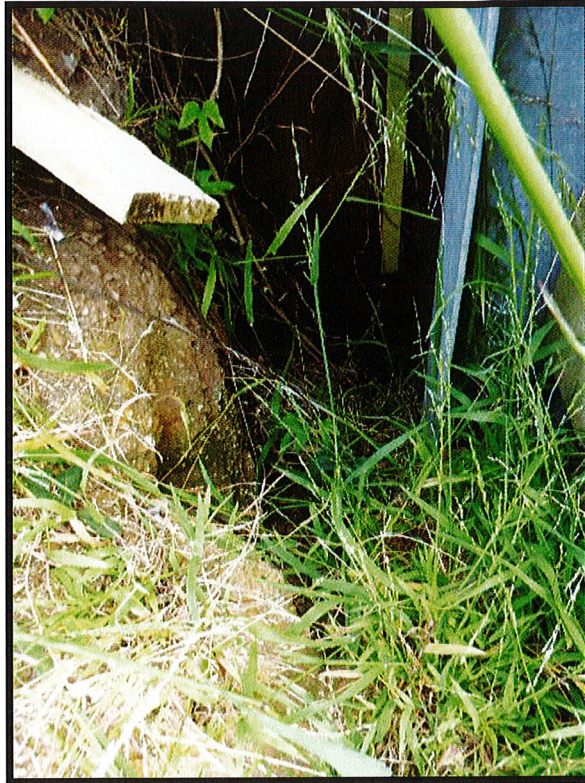
Along with the above, during the recent inspection, a localised void was evident beneath the south-east corner of the property boundary to 42 James Street, with the void appearing to extend beneath the south-west corner of property to the east of 42 James Street [21]. FMG notes that this void was evident during the inspection in November 2020, however it is unclear as to whether this void has increased in size. Based on the location of the void, stormwater run-off can enter the void and enter beneath the property at 42 James Street and the neighbouring site to the east.

Photograph 21 – Photograph captured 13 October 2021. View of localised void beneath the south-east corner of the property boundary to 42 James Street, with the void appearing to extend beneath the south-west corner of property to the east of 42 James Street.
