# Summary of existing information from desktop study

## Previous reports

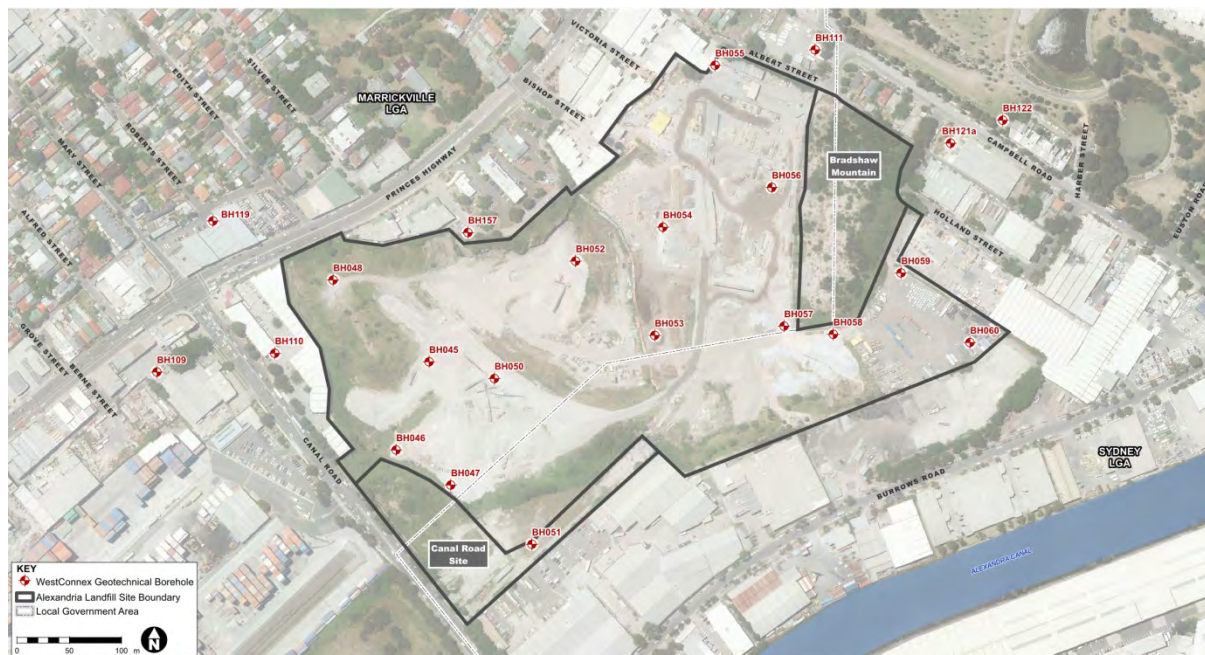
Figure 9 Stage 2 Geotechnical Investigation Borehole Locations

Discontinuities observed within the boreholes will likely contribute to potential instability of the quarry faces. These include sub-horizontal bedding, extremely weathered seams and crushed zones combined with the various joints set. Shear seams and potential faults zones were also observed in (BH055, located in) the north eastern corner of the site and (BH119, located near) the north western boundary of the site. The orientation of the potential faults/shear zone is unknown. A dyke shown in the Sydney 1:100,000 Geological Series Sheet 9130 (1983), was not observed in the boreholes carried in this area.

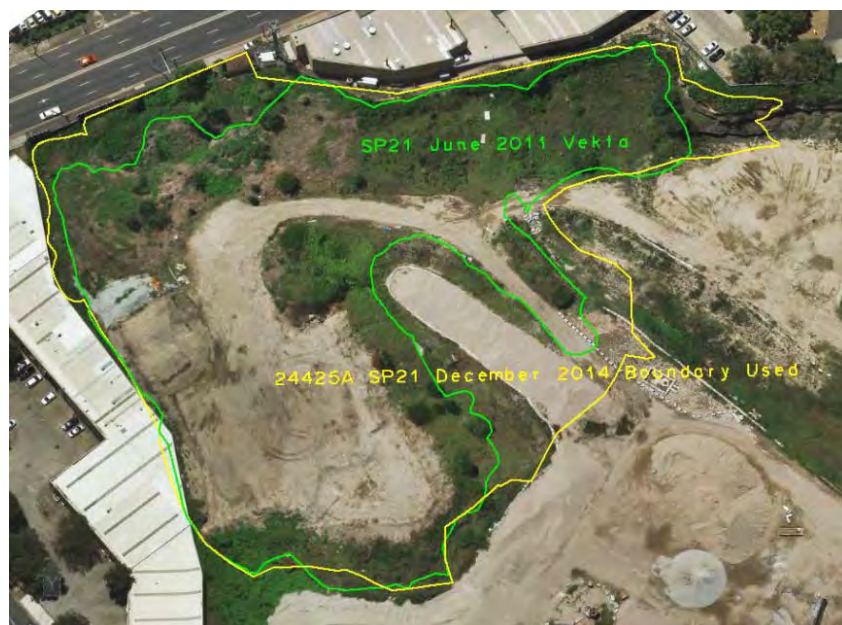
Figure 10 Extent of Stockpile 21 - Extract from AECOM Memorandum March 2015 (Ref 14)

As part of this volumetric assessment, the extent of Stockpile 21 (Bradshaw Mountain) was evaluated as part of a volumetric survey of carried out by both Vekta Pty Ltd and AAM Pty Ltd during this period to determine how much material was to be removed as part of the EPA clean-up notice. Figure 10 indicates the approximate extents of Stockpile 21 based on the volumetric survey information during that period.

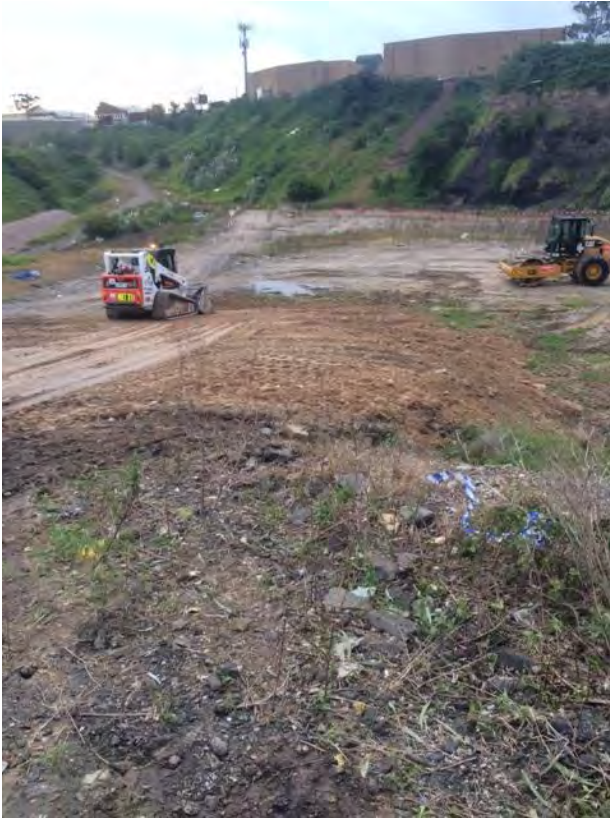
Access Road works for Emergency Slope stability access.
