# **MATAVAI**

## **3 PHILLIP STREET, WATERLOO**

### **STRUCTURAL CONDITION REPORT**

**Report No. DD1375M**

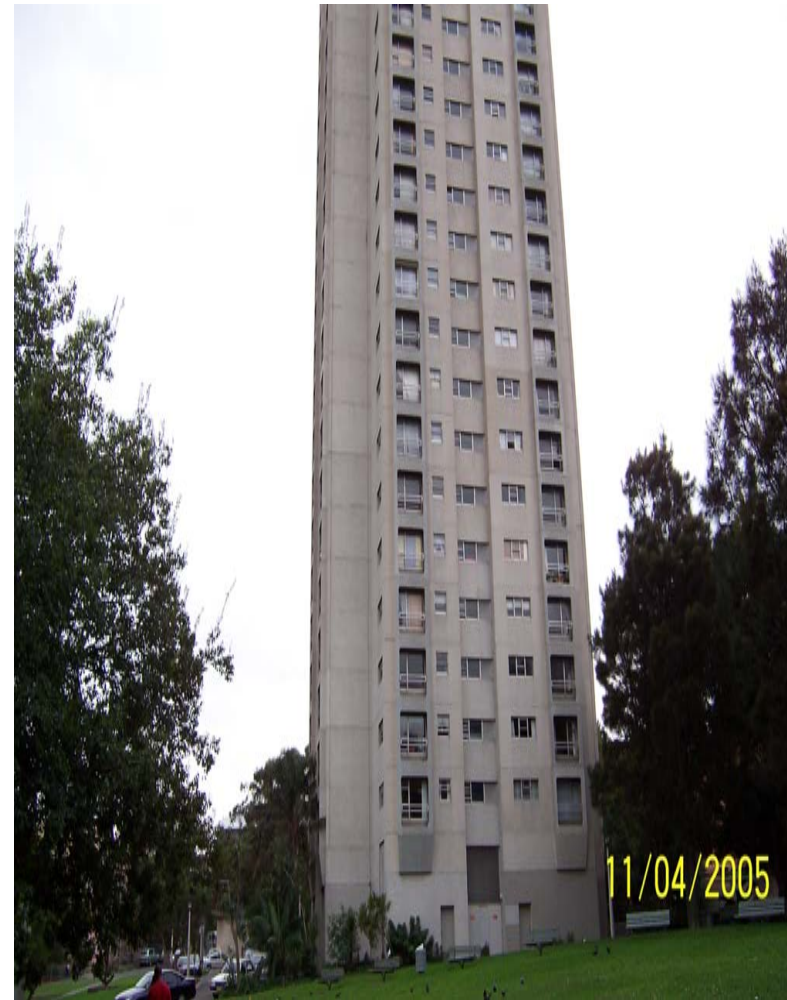
100\_2116.jpg

Level 29 (Internal)	Set ceiling in community room damaged by rain entry.  Remove and replace ASAP	2103, 2104
External facades	Atmospheric pollutants to concrete surfaces. Clean and realkalise all external concrete surfaces and coat with water and pollution repelling protective coating within five years.	2114, 15, 16, 17, 18, 19, 20, 21, 23, 24
External facades	Vertical joints between panels. Replace within ten years.	6933, 34, 36, 37
External facades	Surface pitting & corrosion of aluminium railing in front of windows. Replace within ten years.	2109, 94
External facades	Crack in north east edge of bottom window relief.	005-Appendix C (GBGA0246)

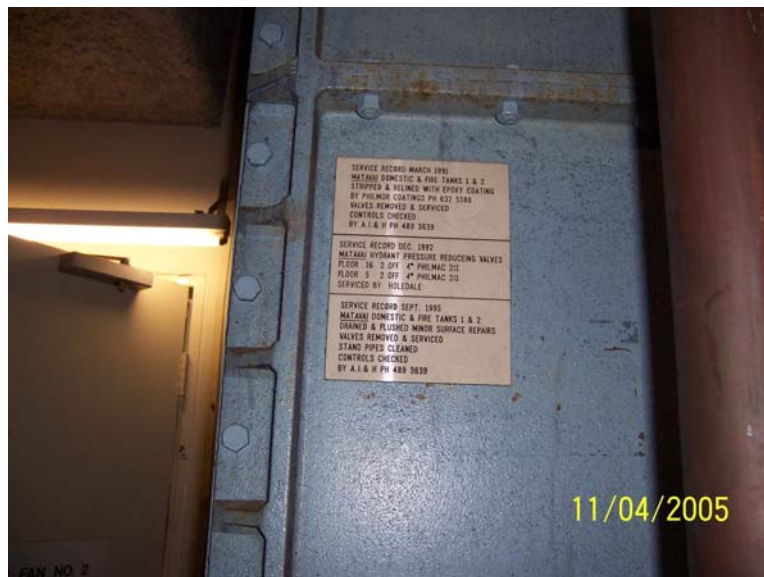
100\_2054.jpg

LOCATION	DETAIL/COMMENT	PHOTO REFERENCE
Water Tanks (Internal)	Two water tanks (approx. 3.0x3.0x2.4m high) above level 29 (plant room level). <ol style="list-style-type: none"> <li>1. Cast iron walls with stainless steel through tie rods in between (photo 12). Replace rods with galvanised rods (24mm dia.), allow 12 rods.</li> <li>2. Thoroughly prepare &amp; paint the inside surface of the tanks with approved epoxy based paint.</li> <li>3. Most of the bearing flat steel plates (12mm thick) below the base of tanks are rusting (photos 10, 11). Remove all flat steel bearing plates and replace with nylon pads between tanks and supporting structure.</li> <li>4. Install sacrificial anodes in each tank.</li> <li>5. Carry out above-mentioned recommendations within three years.</li> </ol>	2054, 55, 62, 63, 64.
Plant room Level (Internal)	Anchoring steel brackets to precast panels. Refer to non-destructive testing results carried out by GBG Australia.	2056, 57 2102
