From: SADEGH-VAZIRI Mehran
Sent: Wednesday, 5 June 2019 2:55 PM
To: O'NEILL Gail; Division 14
Cc: PAOLINI Rob; ROBERTS Tim; MCDONOUGH Grant; DOYLE Michael
Subject: RE: Water inundation from GCCC land to 17 Larentia St Currumbin Waters.

As an update in relation to this matter, Water & Waste have engaged Lamberts to complete further leak detection investigations in addition to our leak detection.

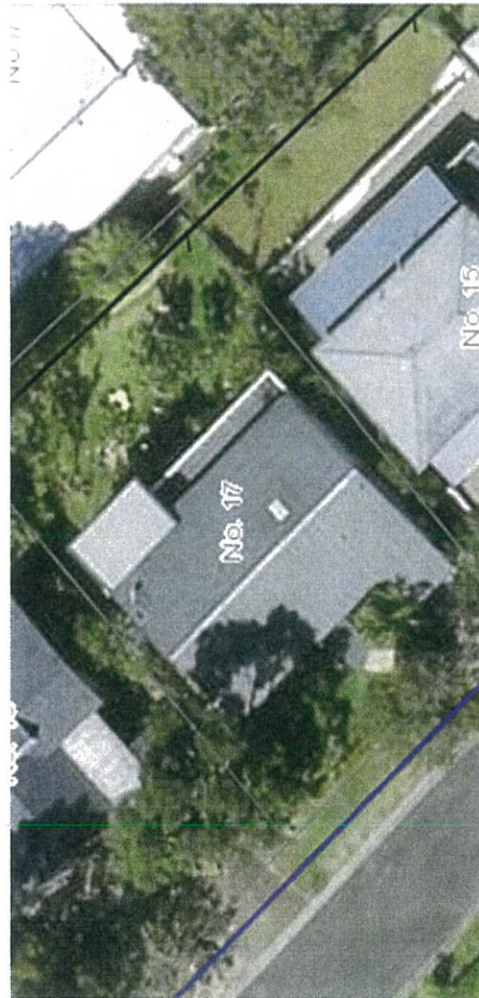
Note: The results indicate that the source of seepage is unlikely to be potable water. The seepage is likely from a natural source i.e. groundwater, stormwe

Comment	Water quality - potable water				
	Mean	Median	Minimum	Maximum	95%ile
	0.012	0.009	< 0.006	0.041	< 0.006
The value is lower than the typical quality of potable water.	0.49	0.47	< 0.05	1.8	1.1
The value is lower than the typical quality of potable water.	0.78	0.8	0.3	0.9	0.9
The value is higher than the typical quality of potable water.	0.014	< 0.01	< 0.01	0.13	0.05
The value is higher than the typical quality of potable water.	0.0021	0.001	< 0.001	0.16	0.007
	0.34	0.24	0.015	2.4	0.887
The value is higher than the typical quality of potable water.	41.8	40	30	61	54
The value is within the typical quality of potable water.	0.277	0.27	0.149	0.525	0.406
The value is within the typical quality of potable water.	7.47	7.4	6.5	9.2	7.9
The value is lower than the typical quality of potable water.	0.085	0.084	0.034	0.15	0.133

As discussed, the results indicate that the source is unlikely to be potable water. I have consulted the Product Quality team reading the results and confirmed that it is unlikely to be potable water. They have made a recommendation to check for any possible leak from the swimming pools located across number 17 Larentia Street, which may be the source.

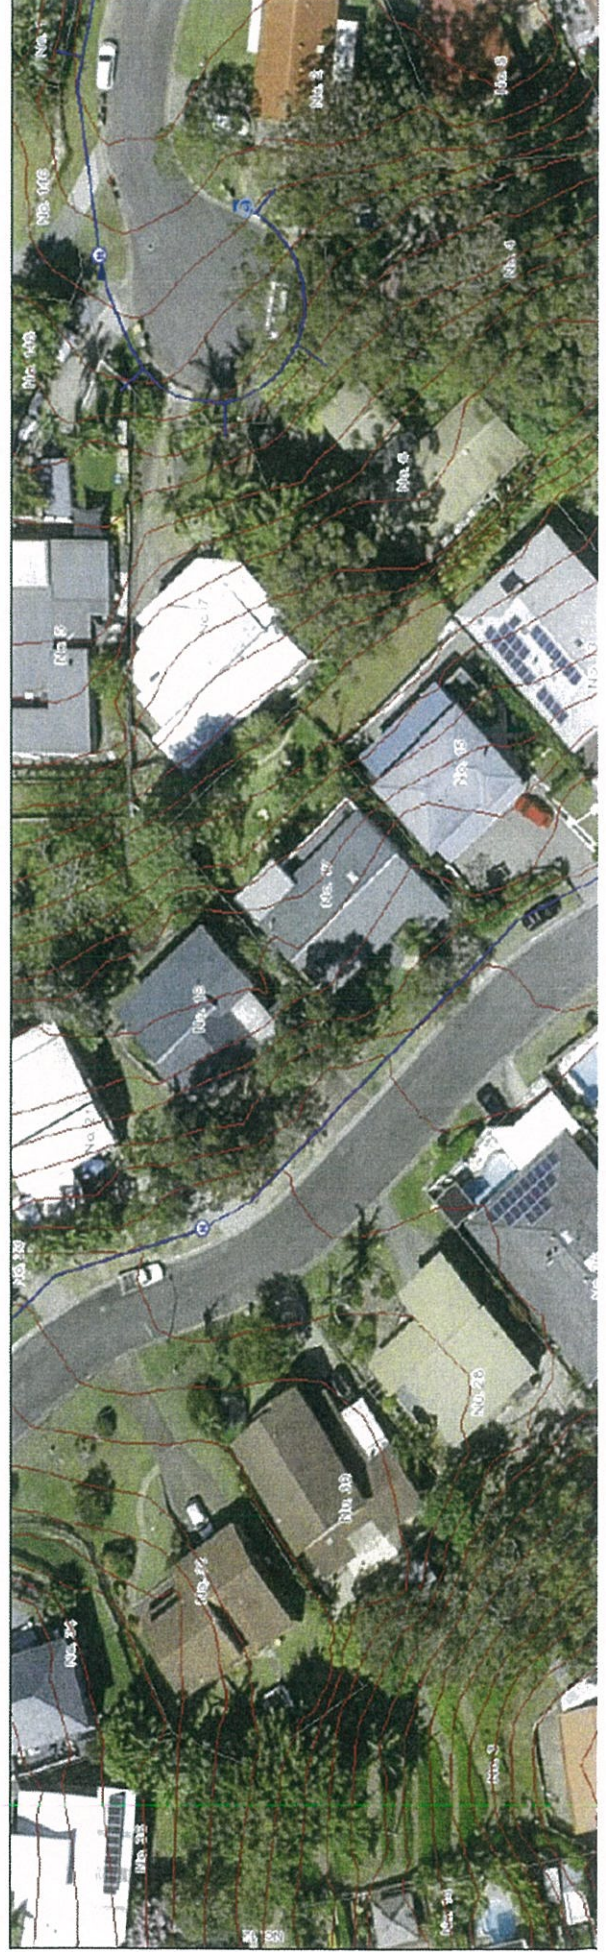
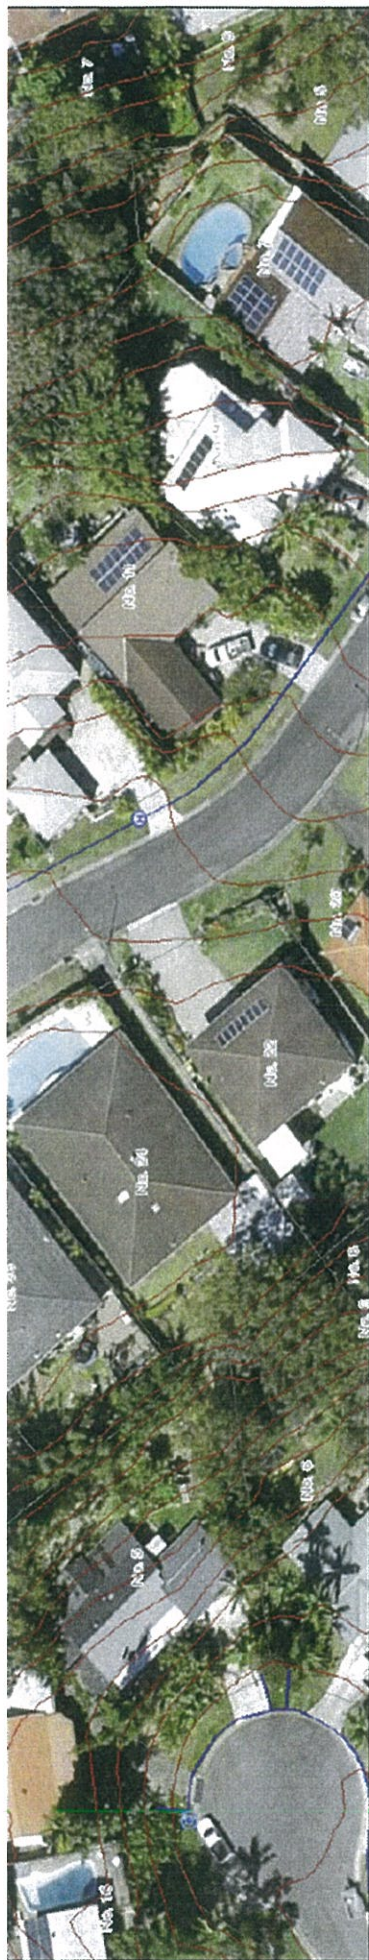
Note: The results indicate that source of the seepage is unlikely to be potable water. The seepage is likely from a natural source i.e. groundwater, stormwater. However, there is a poll across the street that also can be the source.

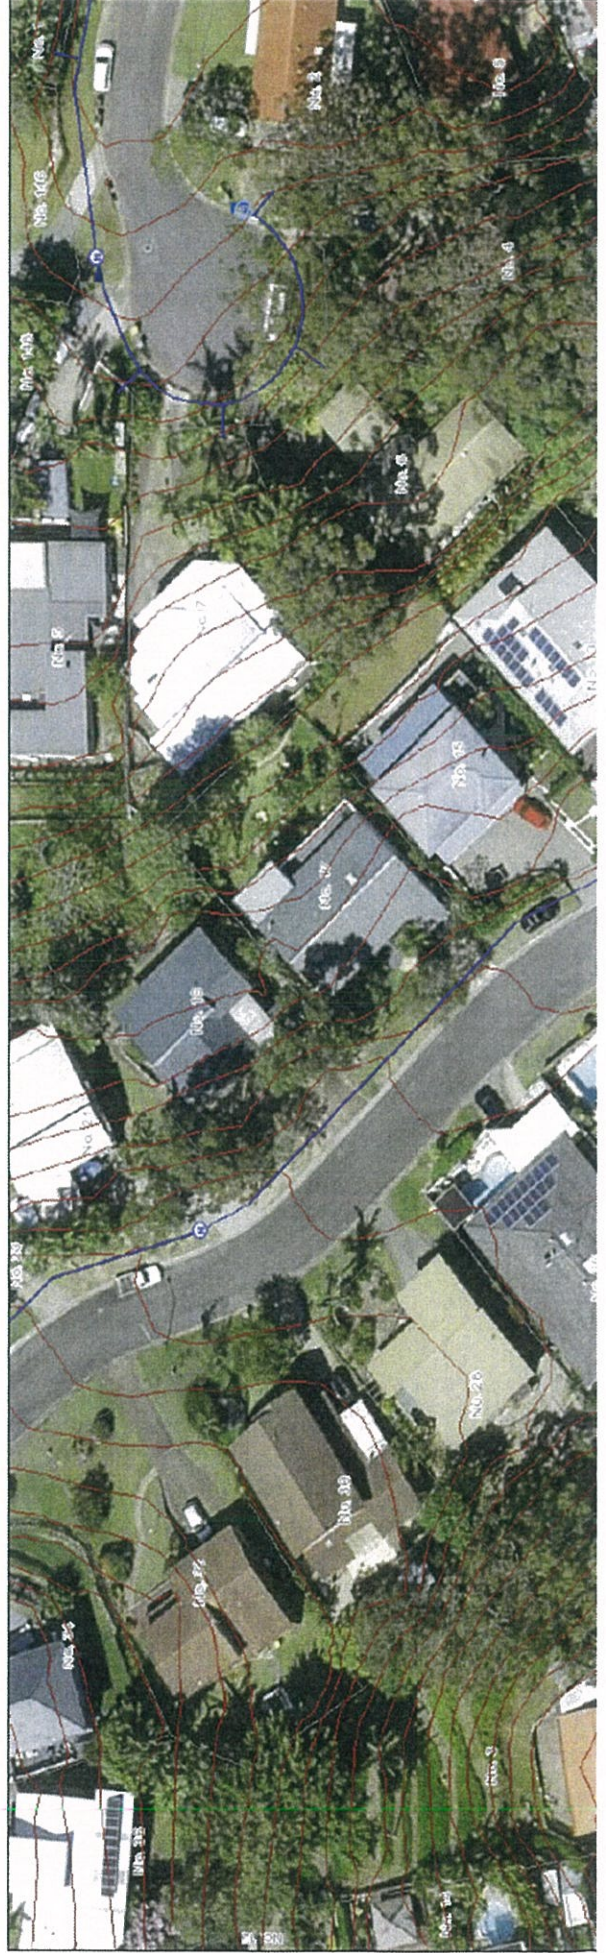
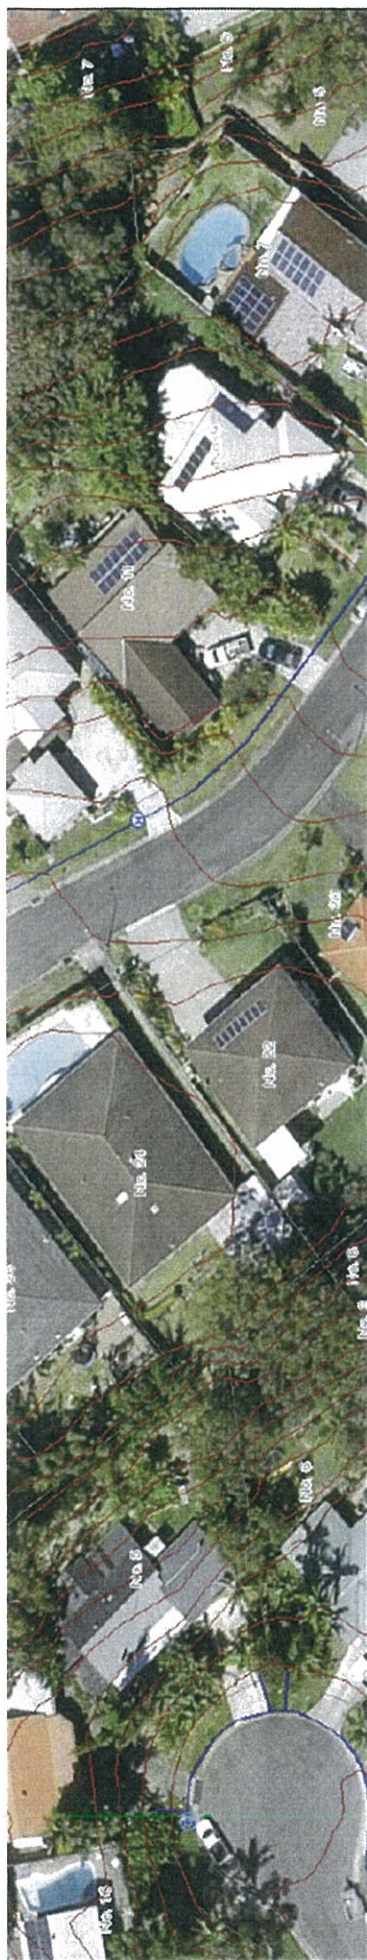
Note: The results indicate that source of the seepage is unlikely to be potable water. The seepage is likely from a natural source i.e. groundwater, stormwater. However, there is a poll across the street that also can be the source.
