Subject: Alexandria landfill slope failure

Site Inspection Report - St Peters Interchange Slope Failure (Previously Dial a Dump Industries)

Geotechnical Desktop Study and Slope Risk Assessment

WestConnex - St Peters Interchange (SPI)

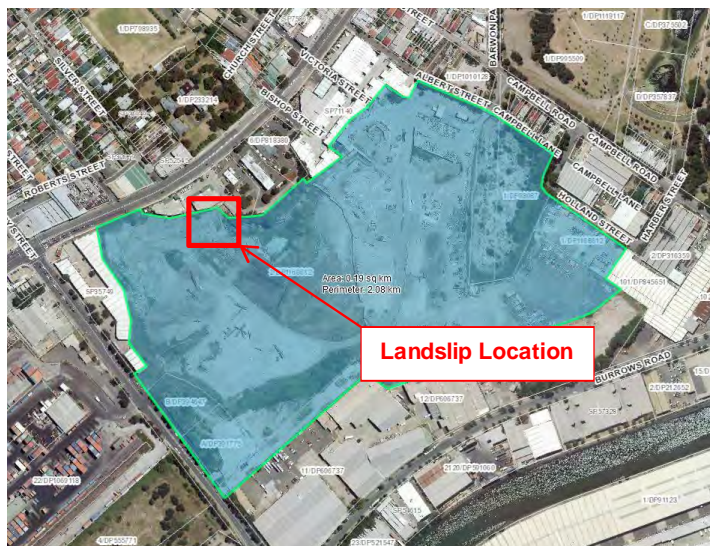
Figure 1 Site Location and landslip location.

The slope failure was noted on the 5th of May 2015. However, the failure could have occurred prior to this date. The slope failure occurred along the northern boundary of the property, adjacent to an industrial estate off the Princes Highway. An approximate location of the landslip is shown in Figure 1 below.

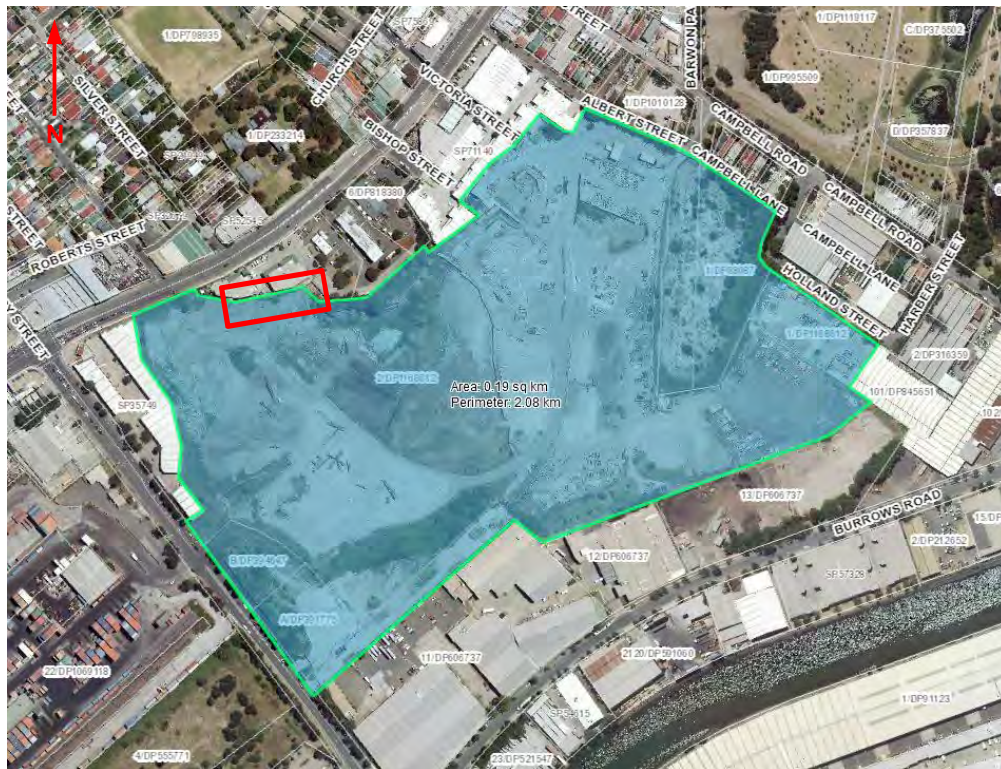
Figure 1 Site Location and landslip location (Not to Scale)

The slope section that has suffered instability is located on the northern boundary of the property, adjacent to an industrial/commercial estate located at 300-310 Princes Highway, St Peters as shown in Figure 1.

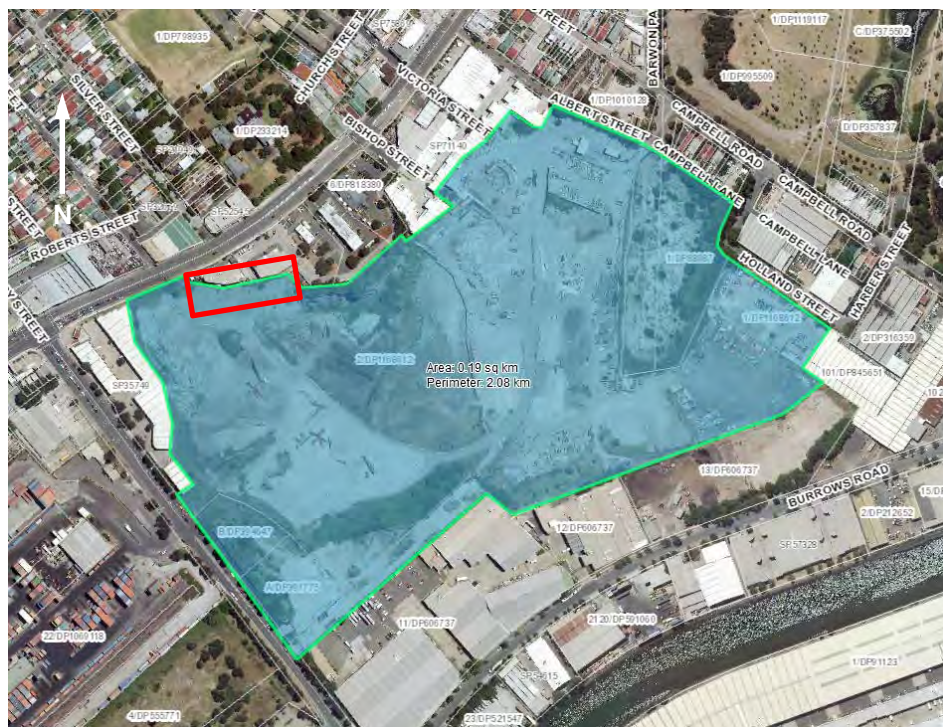
Figure 1 Site plan showing location of recent slope instability (Not to Scale)

The area of slope subject to recent instability is located on the northern boundary of the property, adjacent to an industrial/commercial estate located at 300-310 Princes Highway, St Peters, as shown in Figure 1.

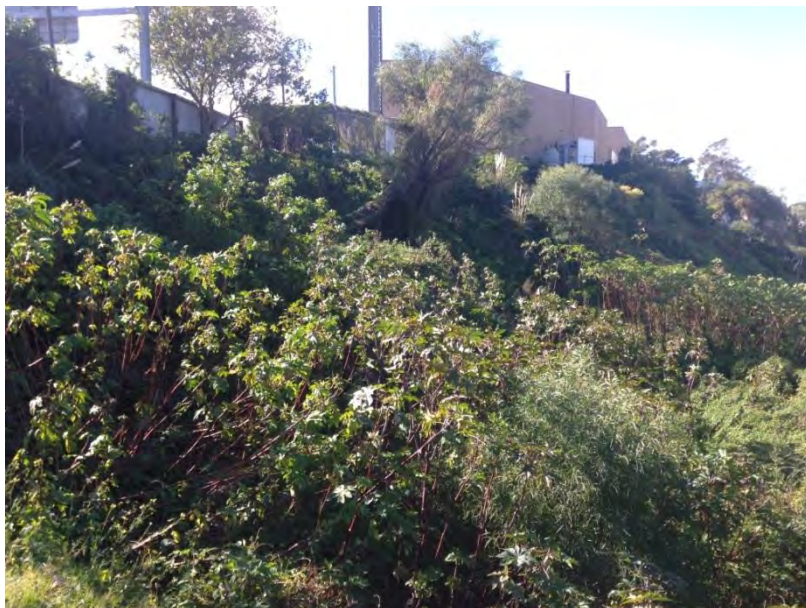
Plate 1-1 - View looking north east along the slope face (slope obscured by vegetation)

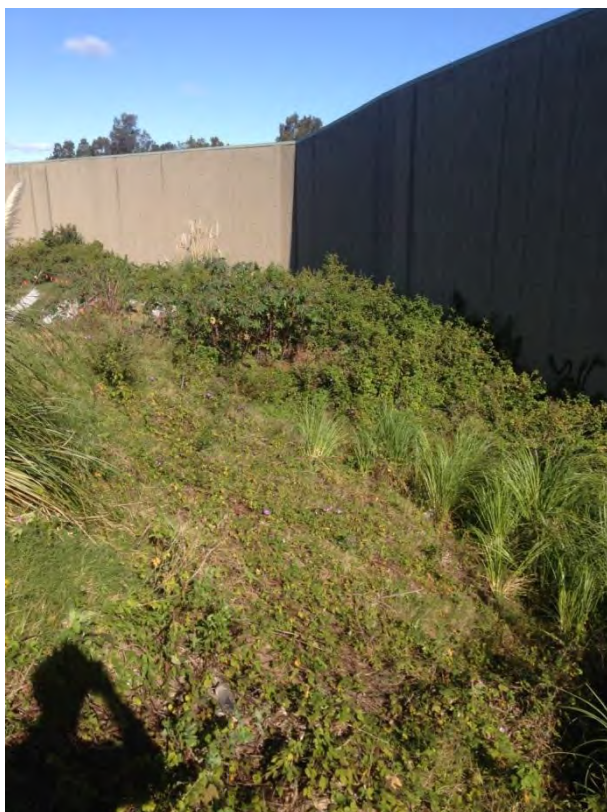
Plate 1-3 - View looking south west adjacent to the existing warehouse

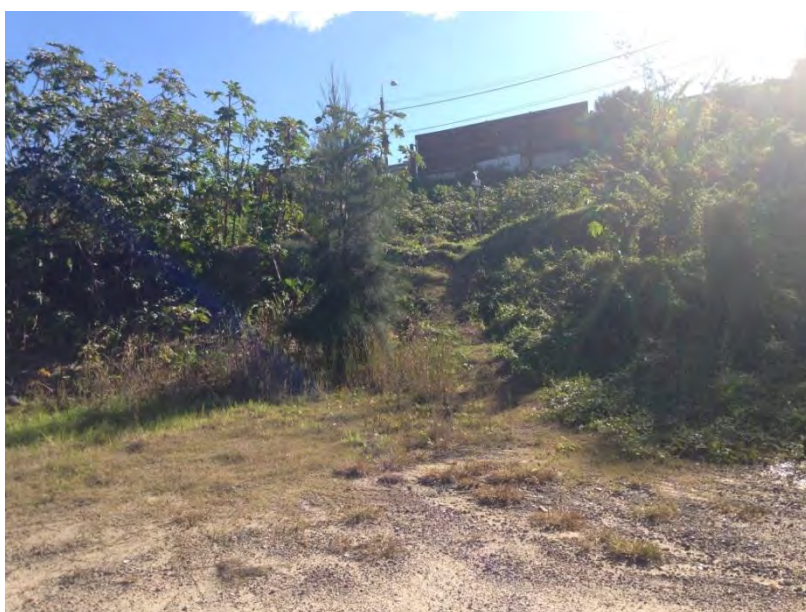
Plate 1-4 - View looking north at slope face

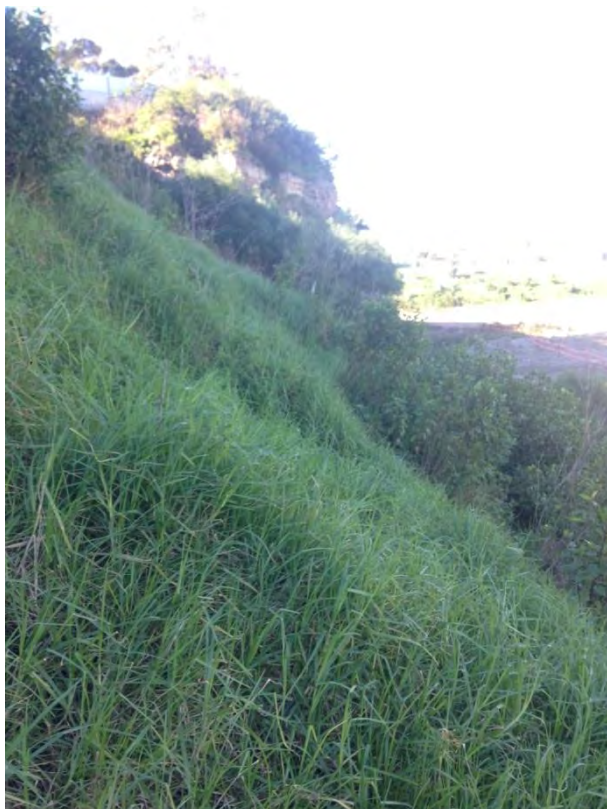
Plate 2-1 - View looking east along the slope face (slope obscured by vegetation)

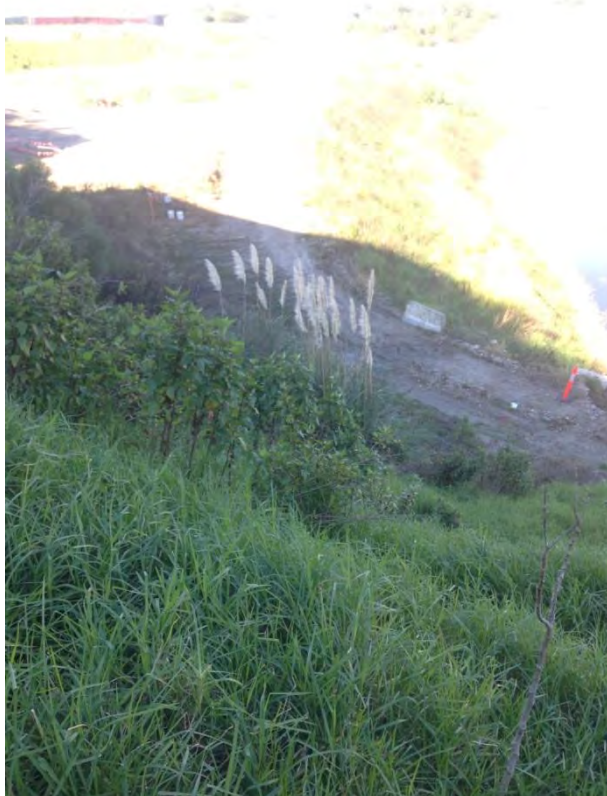
Plate 2-2 - View looking south east along the slope face to the access road at base of the slope

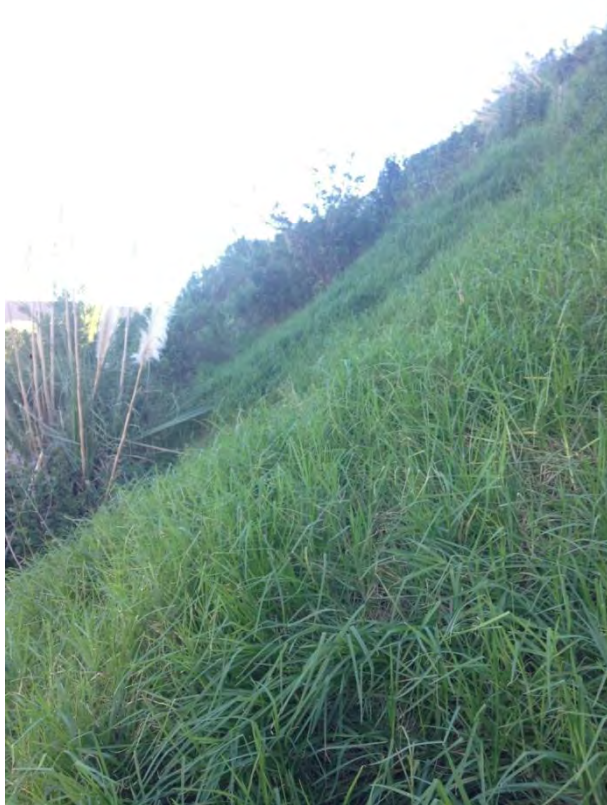
Plate 2-4 - View looking North West along the slope face at potential historical failure

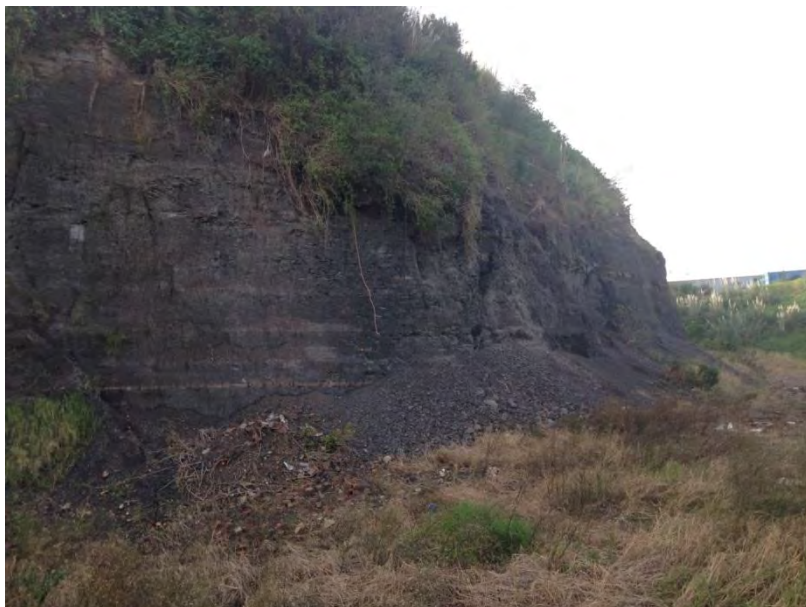
Plate 3-3 - View looking north at exposed quarry face with fill overlying the weathered shale and seepage from bedding

Fretting of exposed quarry faces could be controlled by measures such as shotcrete and pattern rock bolts or draped mesh. Small and large block failures could be supported by spot bolting and using stressed ground anchors. Potential failures could also be removed by controlled scaled of the quarry face using a long reach excavator. Mesh could be draped and bolted onto the quarry face to restrict movement of smaller block failures away from the quarry face.

Hydrostatic pressures along various joints, faults and fractures can triggered block failures at the quarry. Controlling both surface water and groundwater will reduce the potential risk of failure. Surface water should be directed away from the slopes. Horizontal drains could be installed to reduce the risk of groundwater pressures inducing failures.

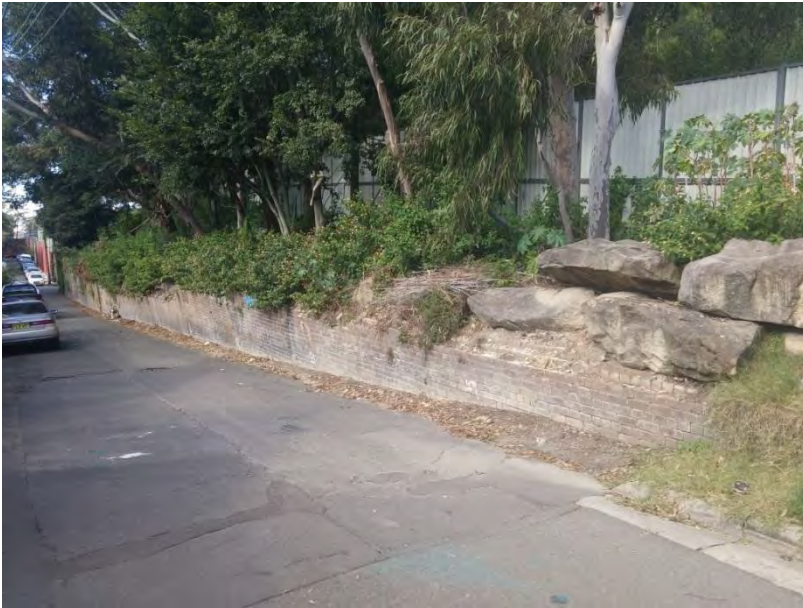
Plate 4-1 - View looking east at gravity wall and boulders

The masonry wall located along Woodley Street and Campbell Lane supports fill. The walls show signs of deterioration and it is unlikely to have been designed to support fill. Due the poor conditions of the masonry wall we recommend that it be either demolished or stabilised. The wall could be potential be stabilised by placing a series of bracing elements such as a post and panel wall. Until the wall is demolished or repaired it is suggested that the footpath be temporality closed and pedestrian be redirected.

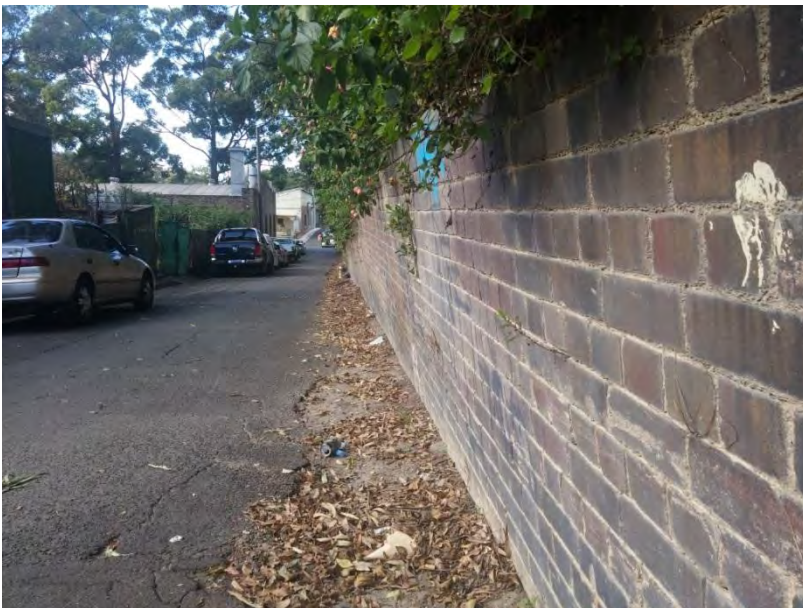
Plate 4-2 - View looking east at leaning gravity wall down Campbell Lane

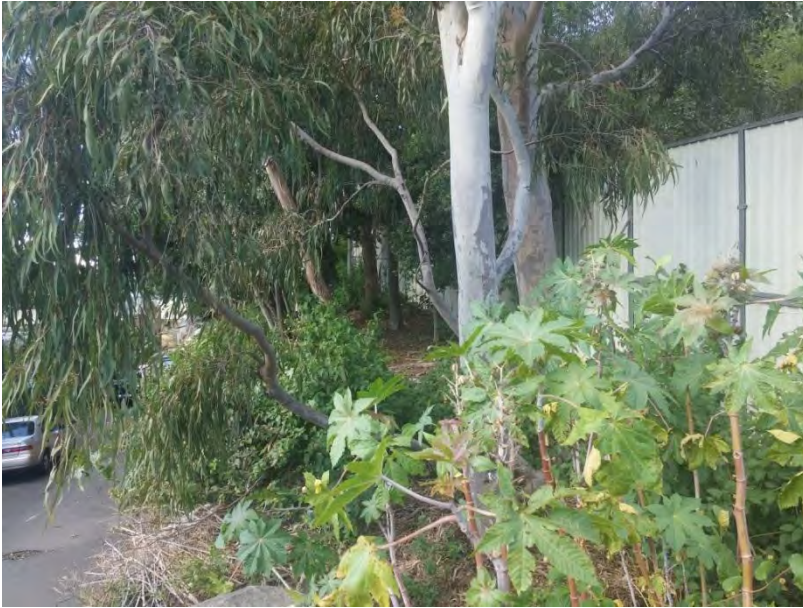
Plate 4-3 - View looking east at vegetation growth on top of the gravity wall down Campbell Lane

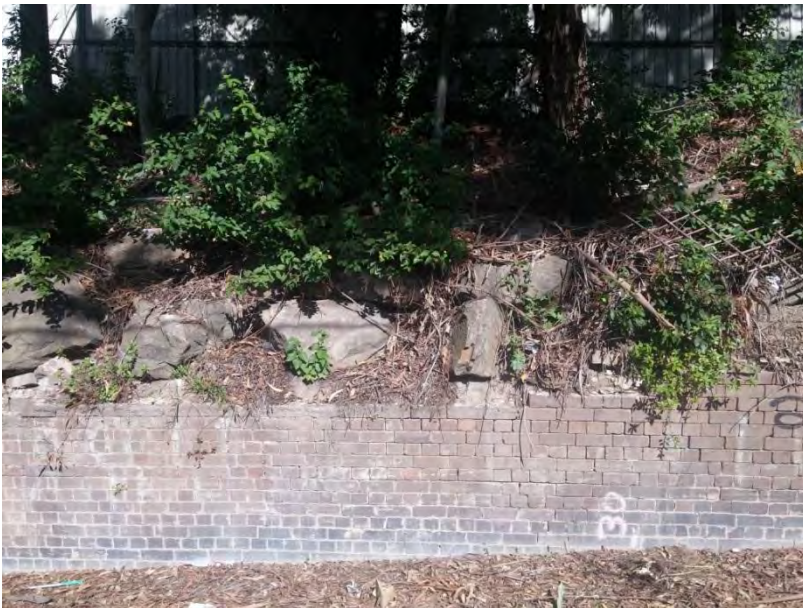
Plate 4-4 - View looking boulders just above the gravity wall on Campbell Lane

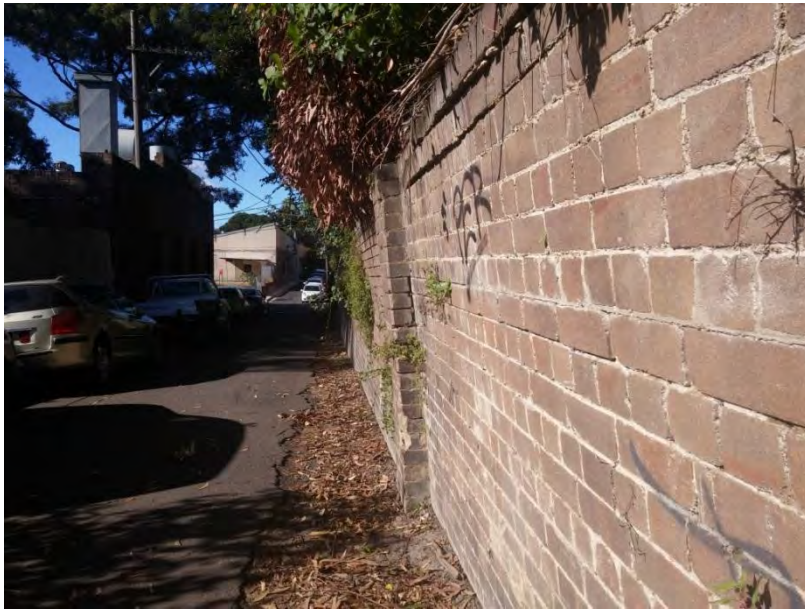
Plate 4-5 - View looking boulders just above the gravity wall on Campbell Lane

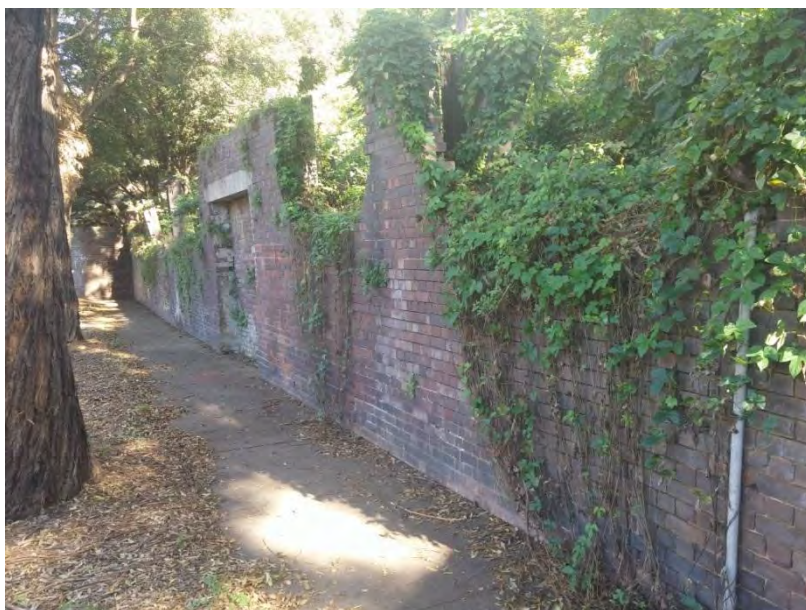
Plate 4-7 - View looking South down Woodley Street at gravity wall

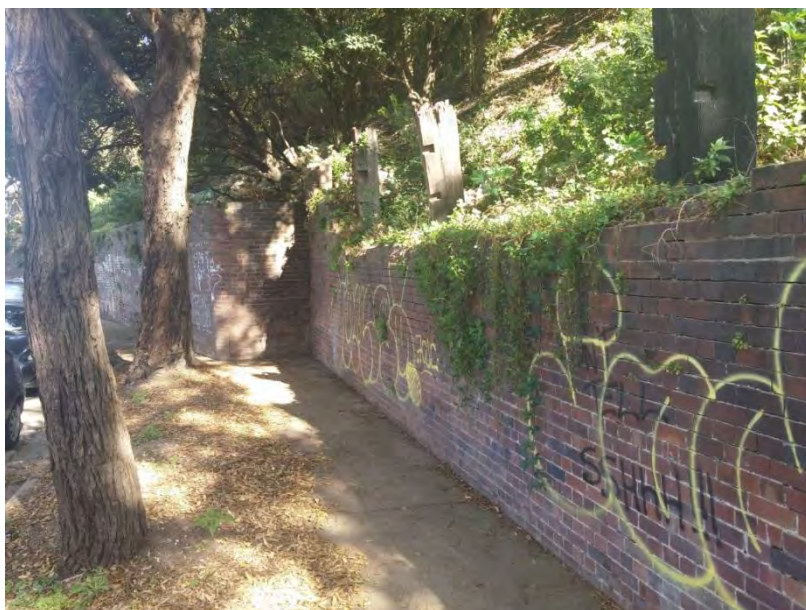
Plate 4-8 - View looking South down Woodley Street at gravity wall

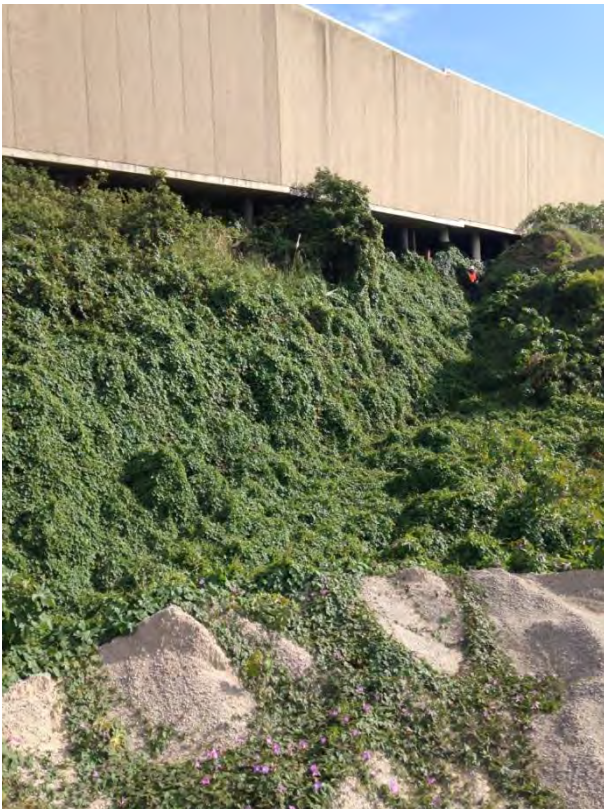
Plate 5-6 – View looking North at overall slope, slope obscured by dense vegetation

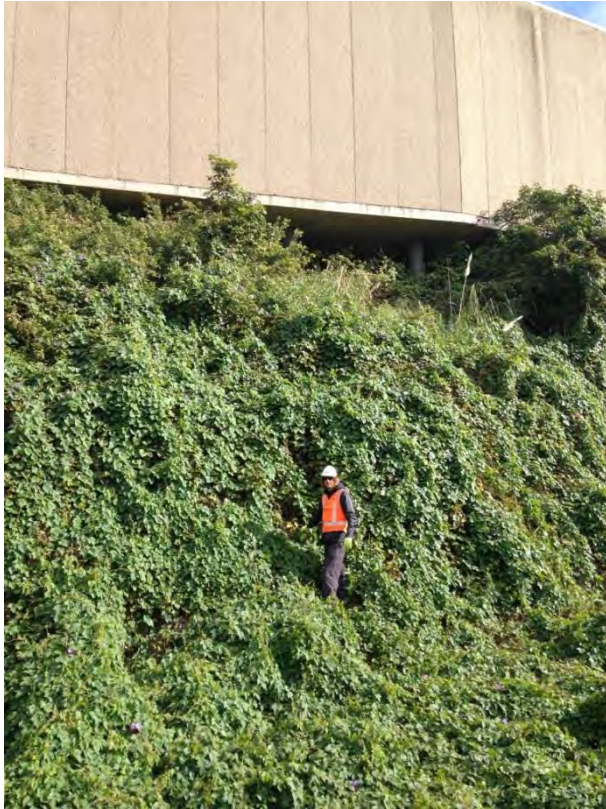
Plate 5-7 – View looking North at overall slope, slope obscured by dense vegetation

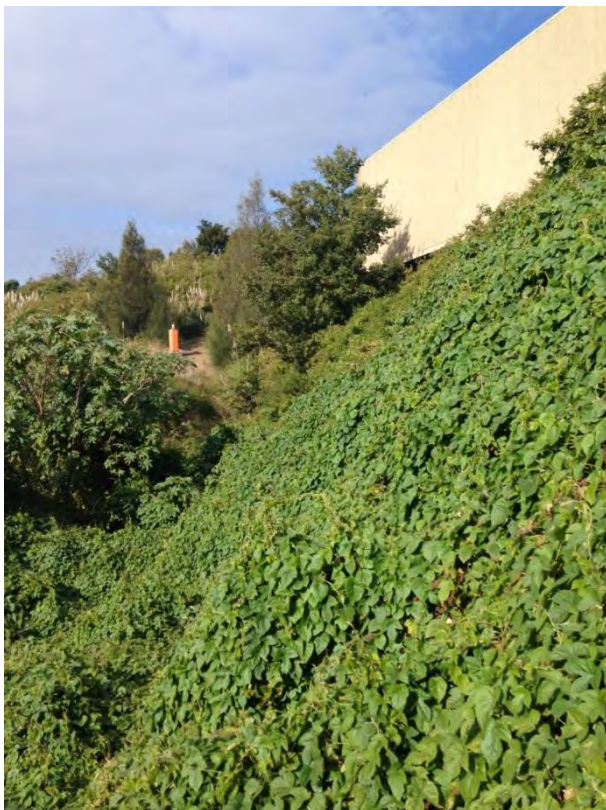
Plate 5-8 – View looking south at overall slope, slope obscured by dense vegetation
